ISO
7146-1

Plain bearings — Appearance and characterization of damage to metallic hydrodynamic bearings —

Part 1: General

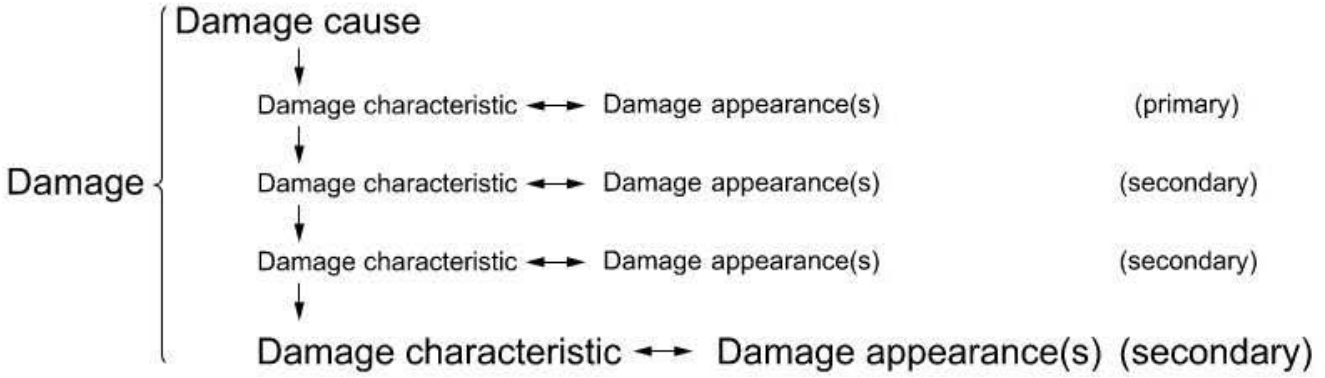
Figure 1 — Damage appearances alter with the progress from primary to secondary characteristics

Damage characterization and damage appearance alter with the progress of damage from a primary to a secondary characteristic (see Figure 1).

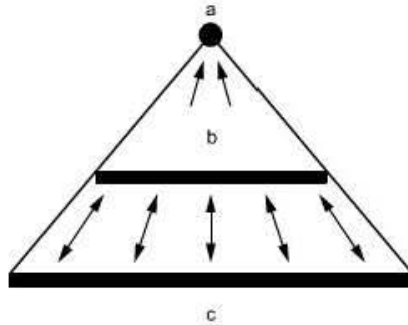
- a Damage cause.
- b Damage characteristics.
- c Damage appearances.

Figure 2 — Damage characteristics provide the basis for analysing the cause

The damage characteristics provide the basis for analysing the cause (see Figure 2).

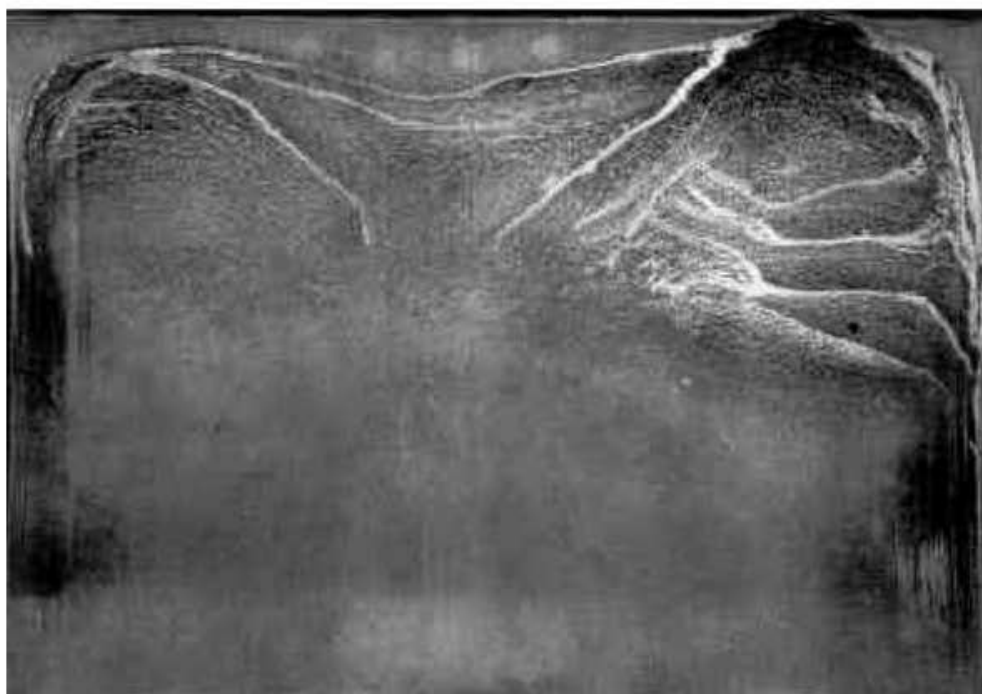
Figure 3 — Creep deformation, shown by crack-free semicircular bulges in the direction of rotation (material: steel/tin-based white metal)

Creep deformation: shallow depressions of bearing material in the region of maximum load and temperature, beginning smooth and ending in crack-free semicircular bulges in the direction of rotation, sometimes like crests of waves (see Figure 3).

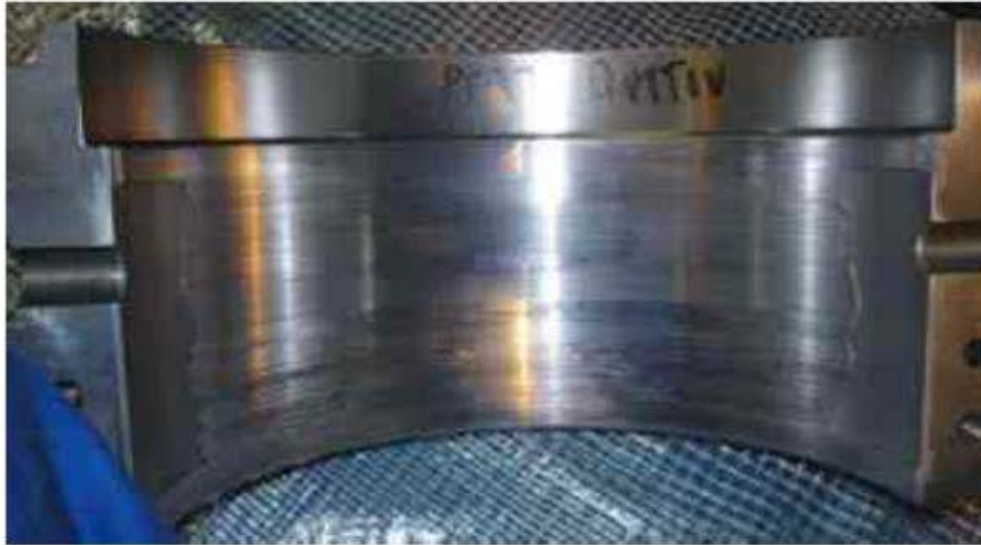
Figure 4 — Propeller shaft bearing, showing the effects of too slow a speed in relation to load capacity (material: steel/tin-based white metal)

Traces of mixed lubrication (see Figure 4), depositions, thermal cracks.

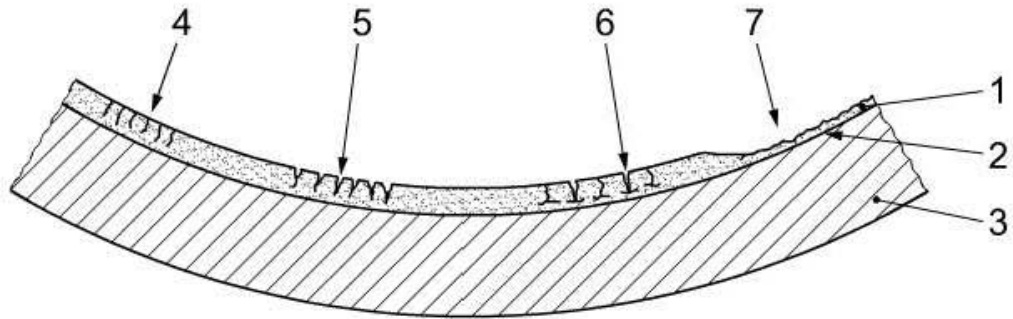
| 1 lining material | 5 eroded cracks |
| 2 bonding area | 6 cracks with perpendicular propagation |
| 4 cracks | |

Figure 5 — Schematic diagram of progress of fatigue cracks

Lining material from the backing is the final result of the development of fatigue cracks (see Figure 5).

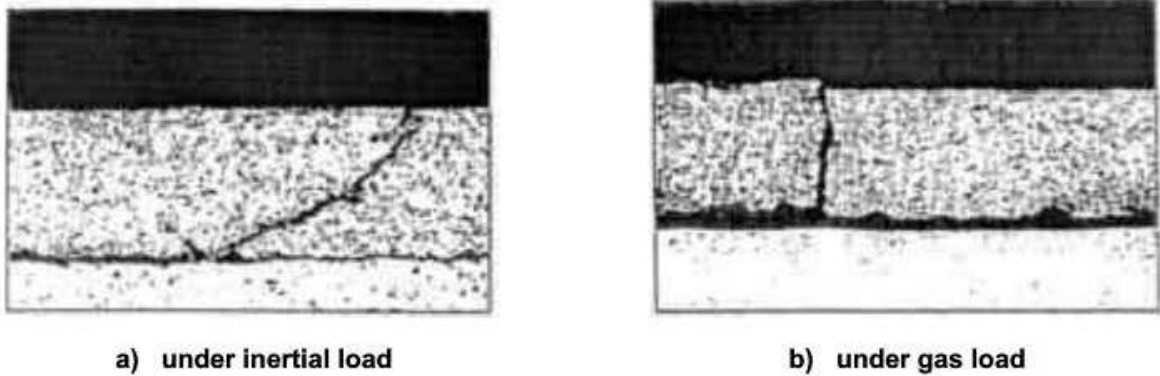
**Figure 6 — Typical fatigue cracks of internal combustion engine bearing
(material: steel/aluminium alloy)**

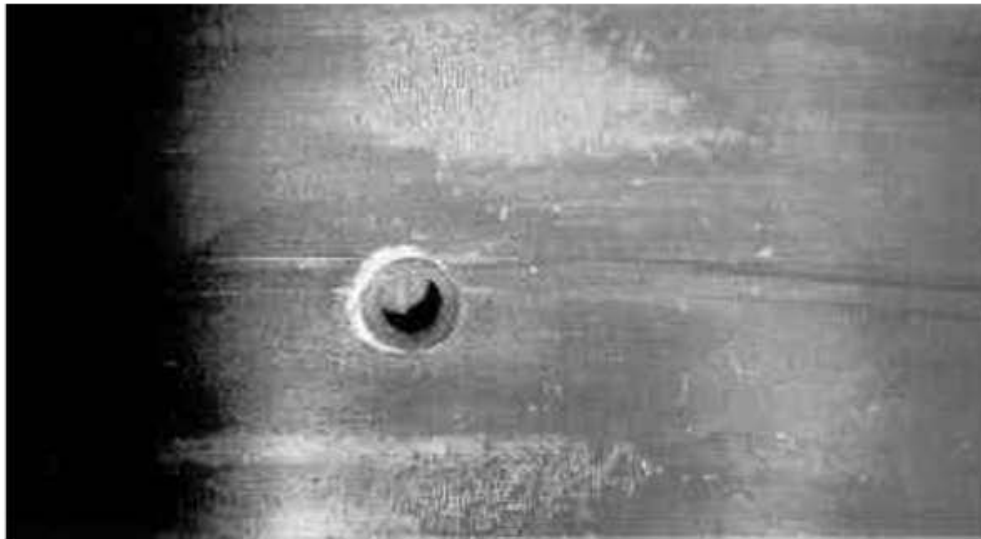
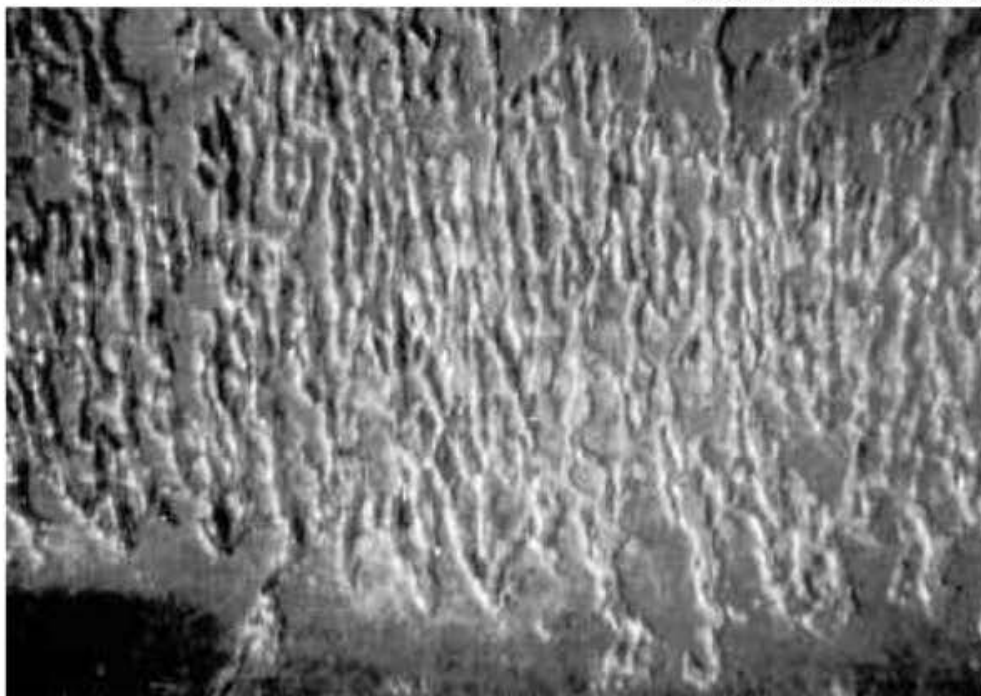
b) section from Figure 7 a) showing the lower half at increased magnification

Figure 7 — Cracks in the electroplated overlay (material: steel/lead bronze/electroplated overlay)

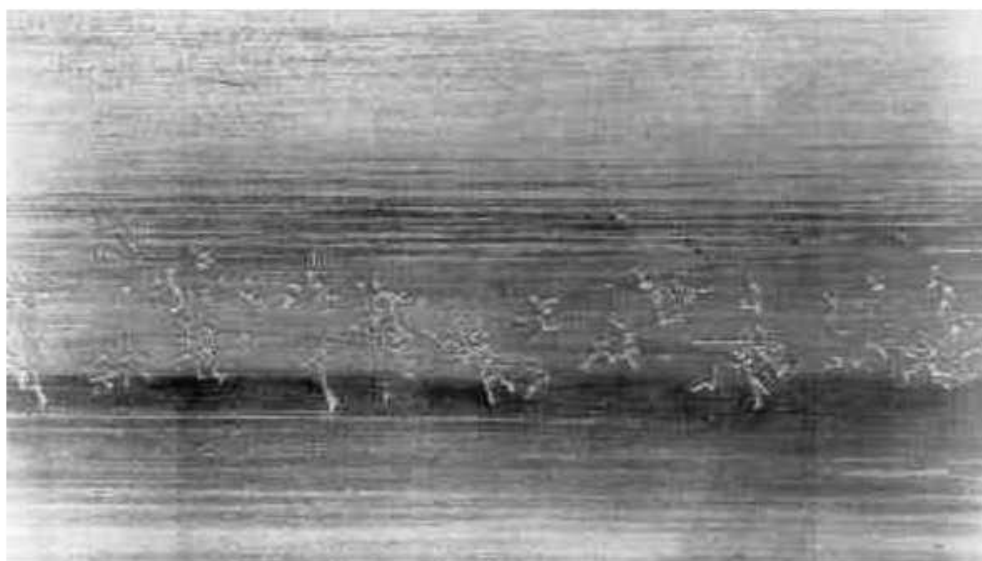
Figure 8 — Cracks in the overlay of a multilayer bearing in a narrow area of high loading (material: steel/lead bronze/electroplated overlay)

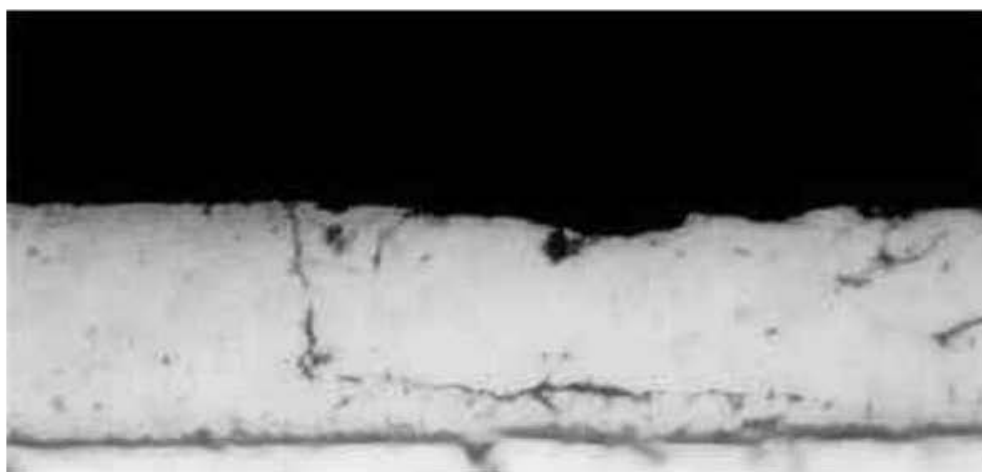
NOTE The crack runs at a small distance from the bonding area.

Figure 9 — Section of spalled layer (material: steel/tin-based white metal)

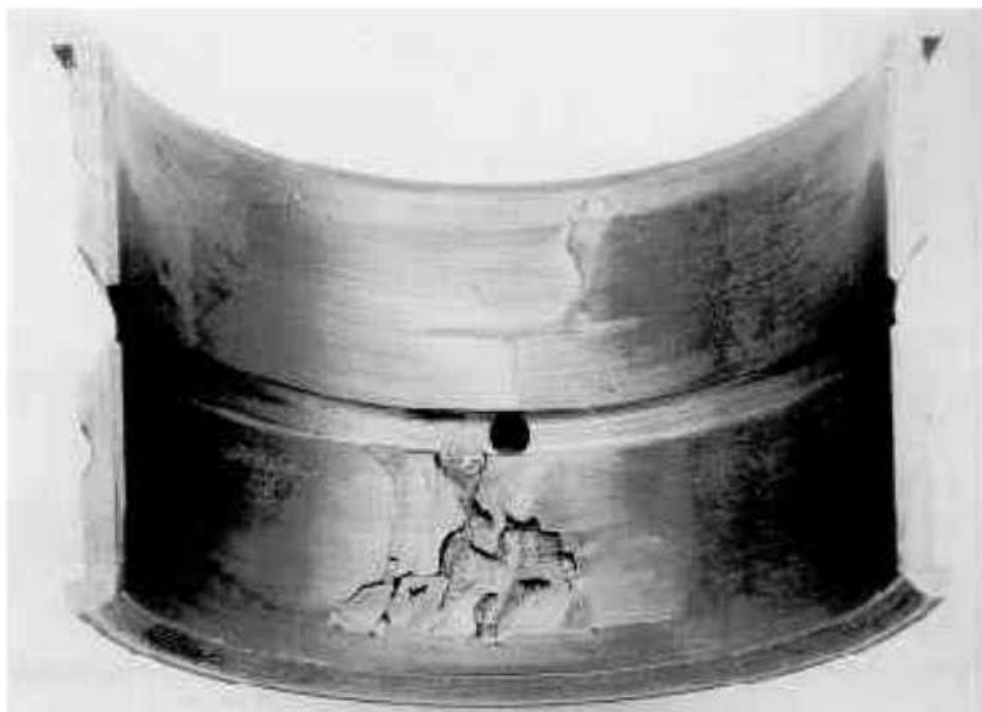
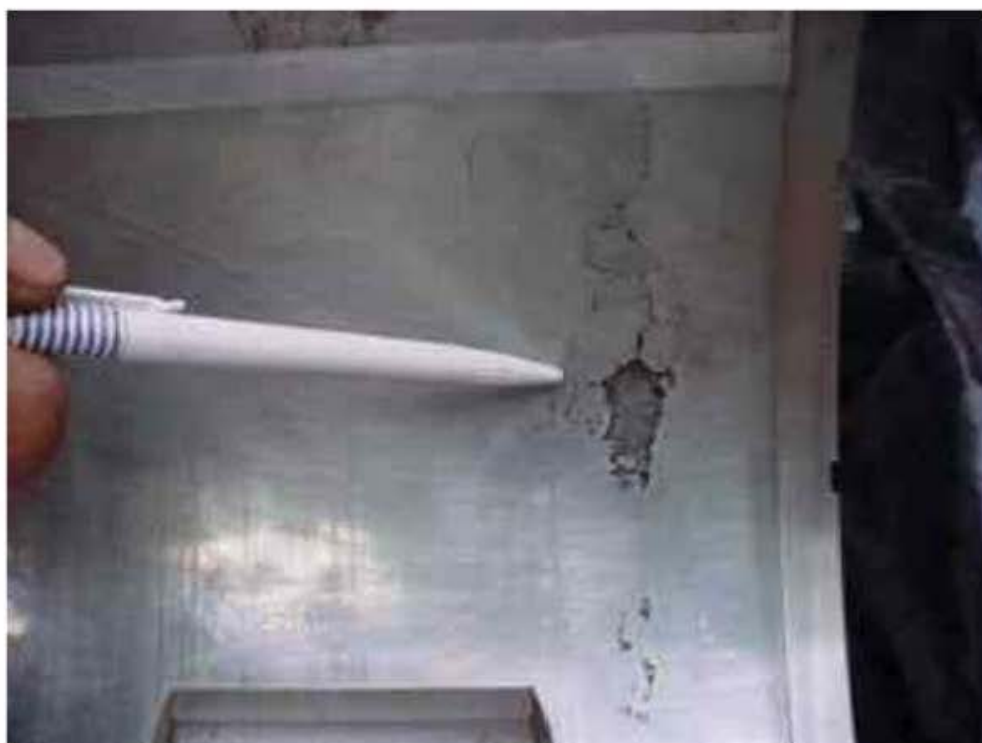
**Figure 10 — Fatigue cracks and material relief by dynamic overload
(material: steel/tin-based white metal)**

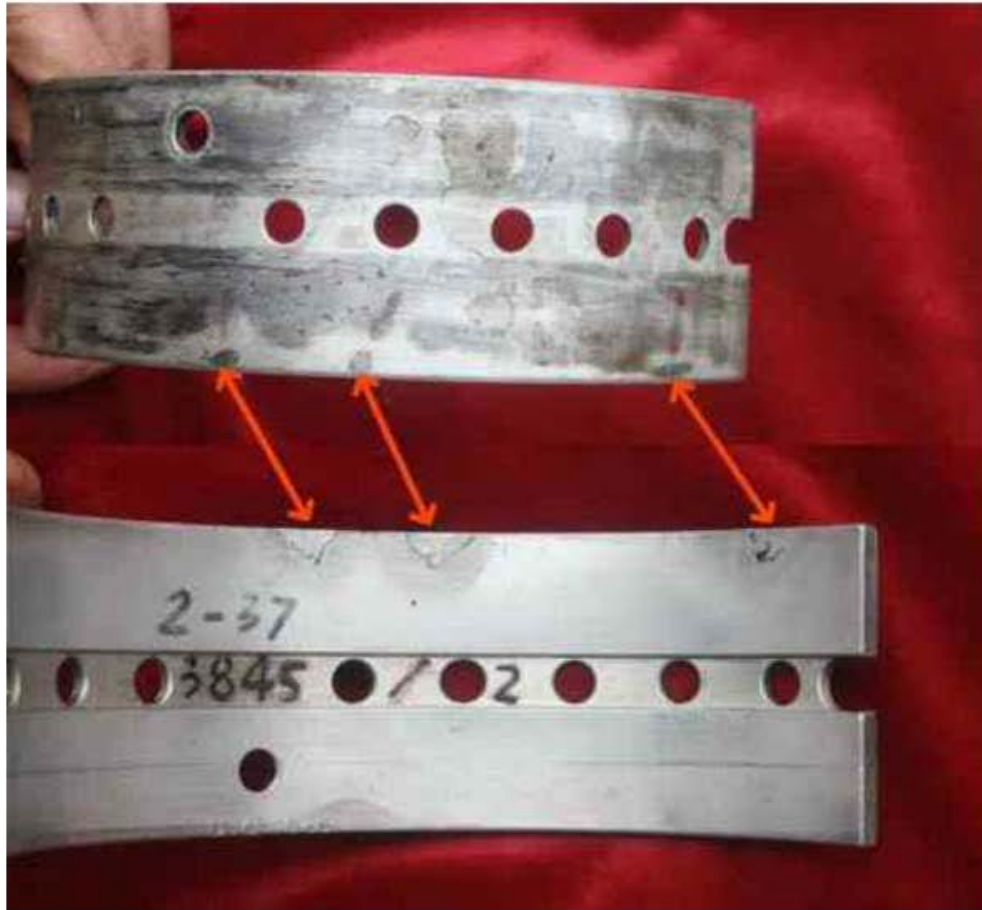
**Figure 11 — Material relief by dynamic overload because of insufficient fit on the bearing back
(see also 7.2)**

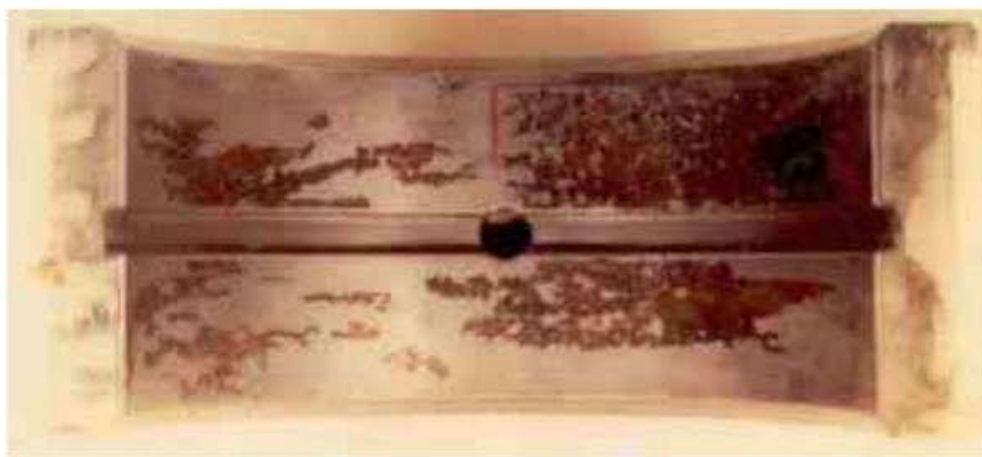
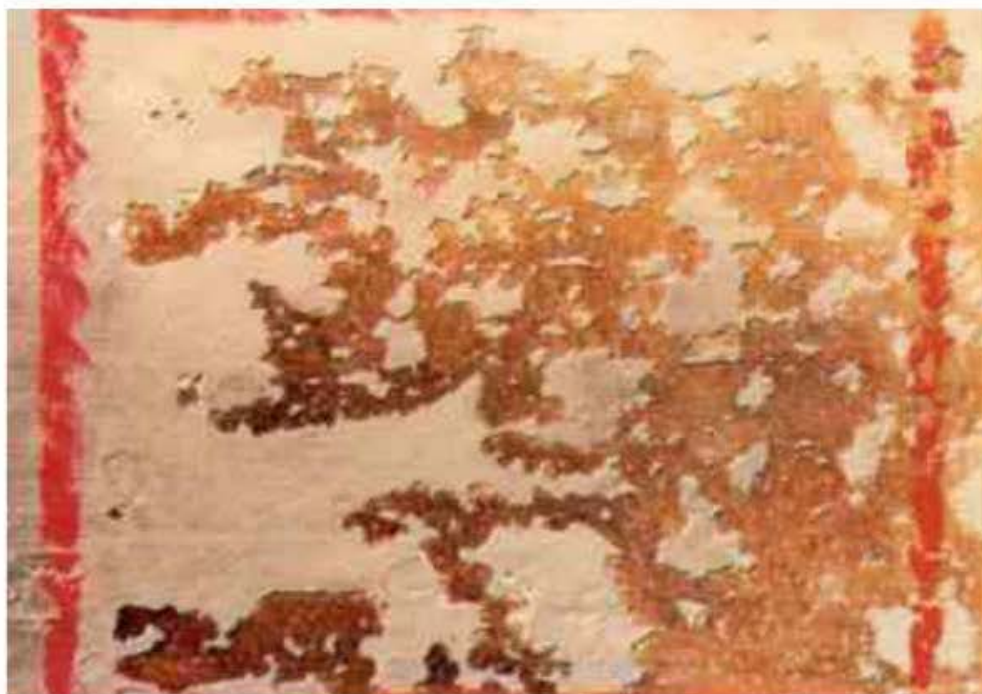
b) section from Figure 12 a): clear illustration of the defect at increased magnification

Figure 12 — Detachment of the overlay leaving occasional residual islands relieved by a dark background (material: steel/lead bronze/electroplated overlay)

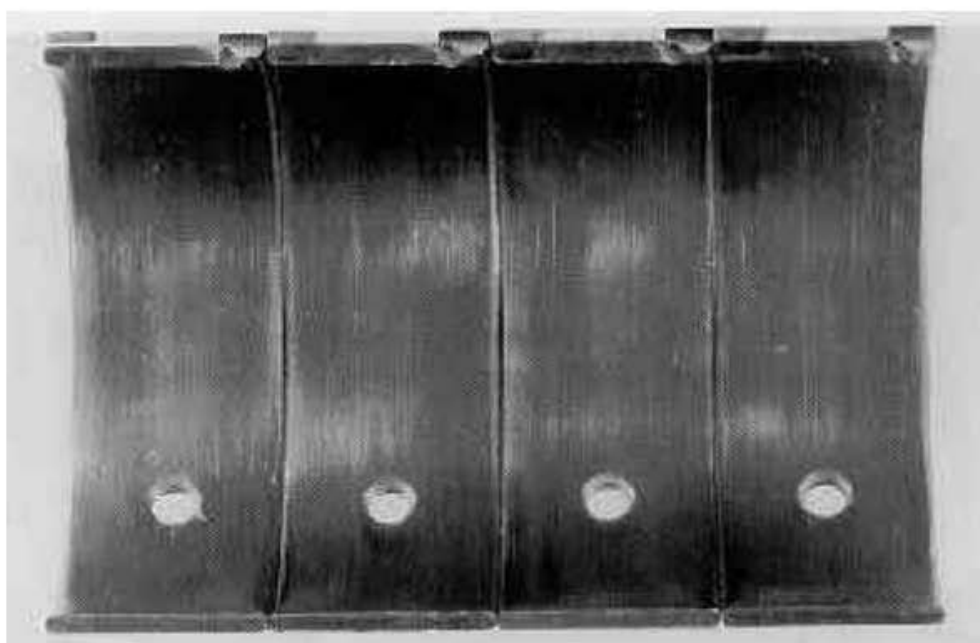
Figure 13 — Running-in polishing and burnishing in the main loaded area of a thin-walled bearing (material: steel/AlSn)

Polishing happens during a short period of mixed lubrication on start and stop conditions. As long as this polishing does not give rise to a detectable reduction in wall thickness, such running-in marks are normal. This is not damage in the sense of the definitions of this part of ISO 7146 (see Figure 13).

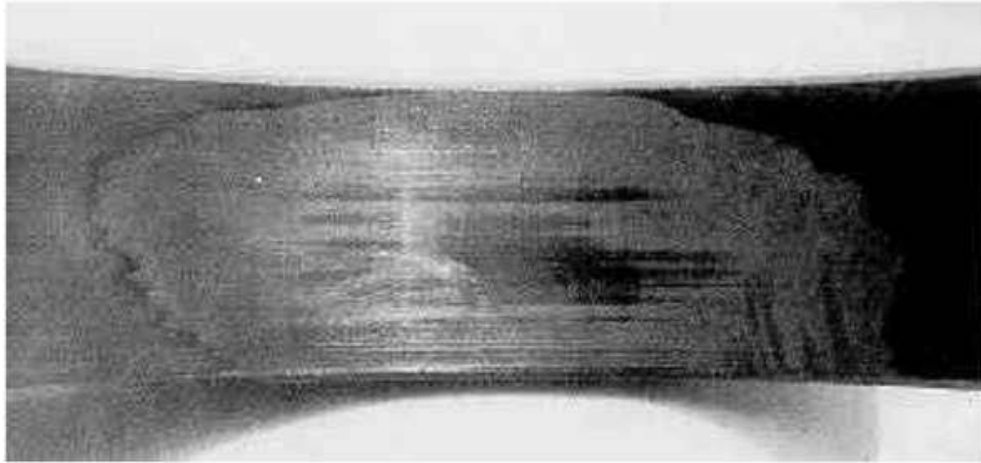
Figure 14 — Abrasive wear of the overlay in the main loaded area on a thin-walled bearing (material: steel/lead bronze/electroplated overlay)

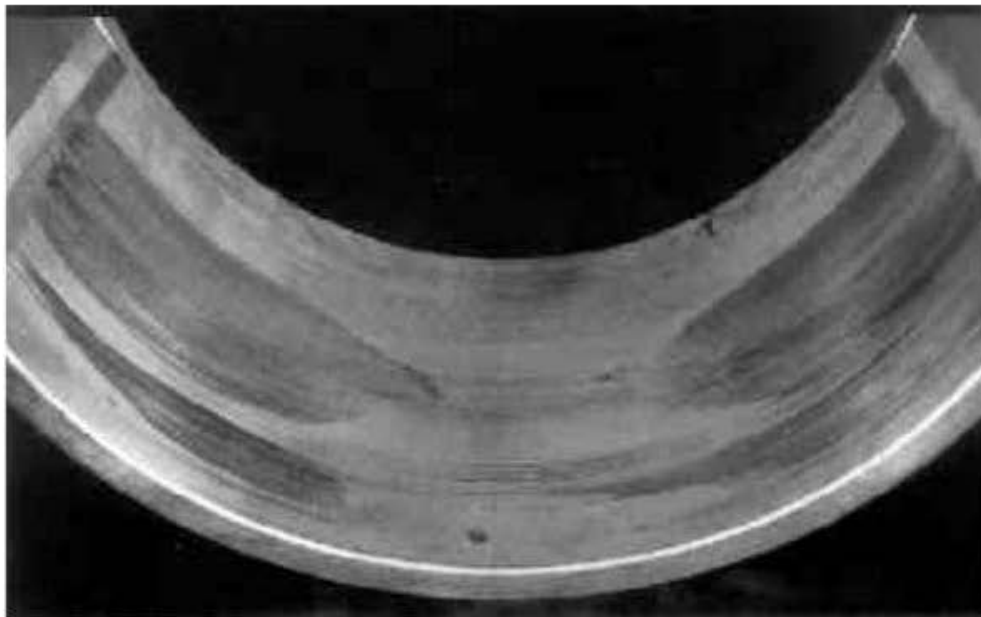
Figure 15 — Abrasive wear near the ends of the bearing (joint face area) in a thick-walled journal bearing, due to faulty mounting (material: steel/tin-based white metal)

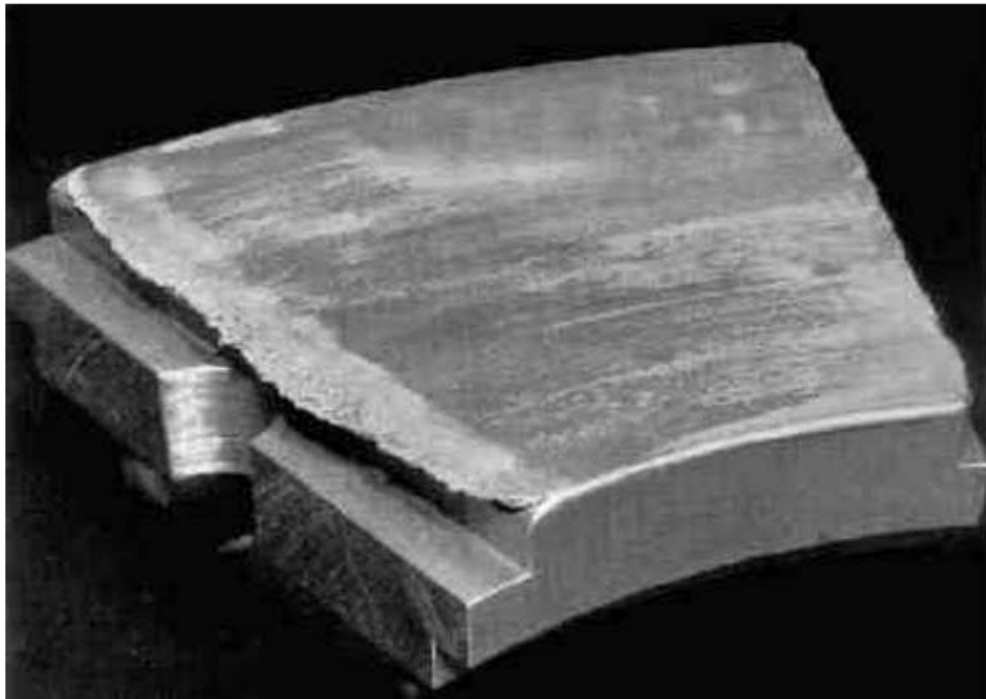
Figure 16 — Wear by friction due to segment assembling on different levels — worn material from one segment deposited on the leading edge of the next segment in the direction of rotation — the segment shown gets a reduction in oil supply (secondary damage characteristic: loss of lubricant) (material: steel/tin-based white metal)

Segmented plain bearings experiencing appreciable wear at high rubbing surface temperatures often initially show traces of mixed lubrication; later, worn material from one segment is deposited on the leading edge of the next segment in the direction of rotation (see Figure 16).

Normal wear across full width (see Figure 16)

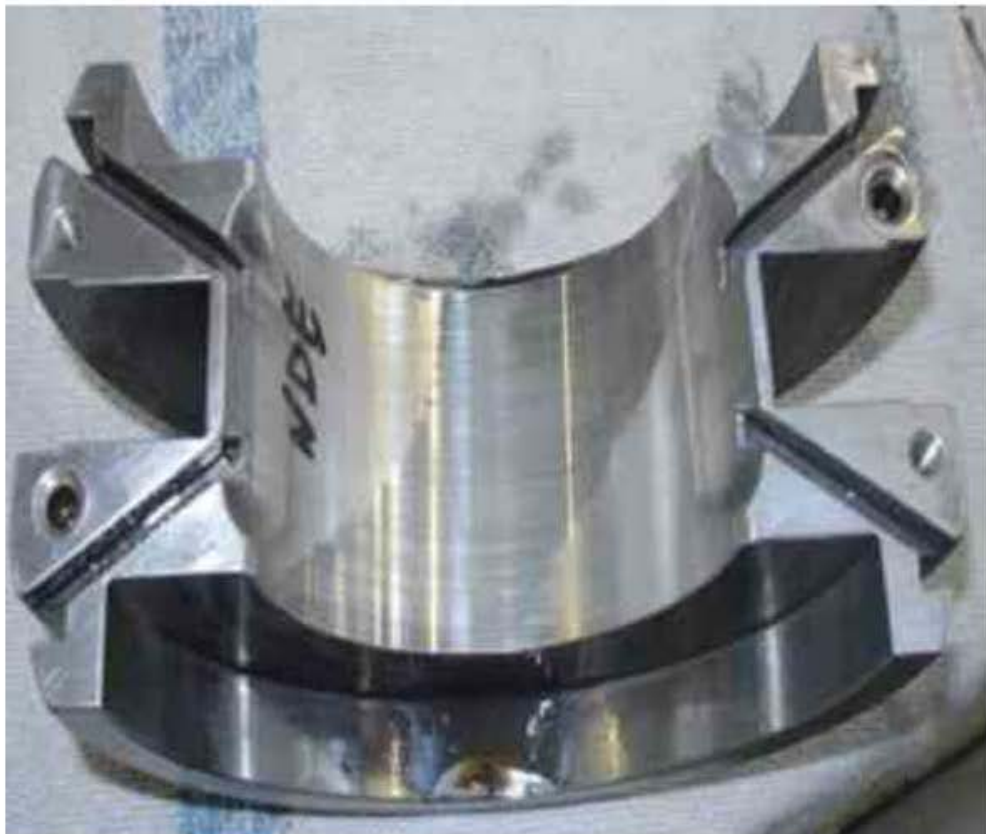
Figure 17 — Wear by misalignment between bearing backing and shaft (material: steel/tin-based white metal)

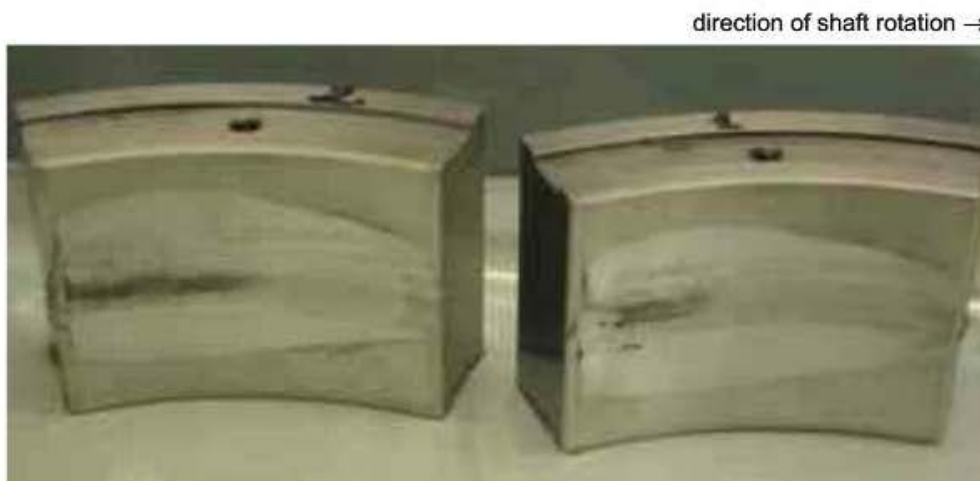
Figure 18 — Creep deformation due to overheating with formation of black depositions (material: steel/tin-based white metal)

Creep deformation: shallow depressions of bearing material in the region of maximum load and temperature, initially smooth and ending in crack-free semicircular bulges in the direction of rotation, sometimes like crests of wave (see Figure 18).

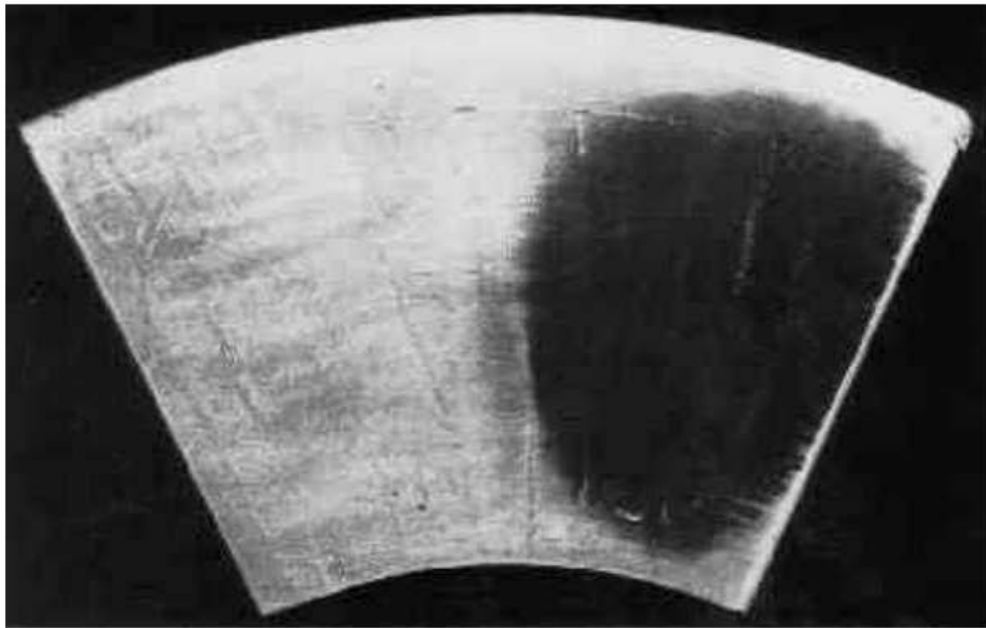
**Figure 19 — Thrust bearing tilting pad with deposits of oil carbon
(material: steel/tin-based white metal)**

Deposition: overheating leads to ageing of the lubricant, its thermal decomposition, and finally to depositions. The phenomenon is concentrated in the minimum oil film region, or in other places in the oil circulatory system, occurring more severely when oil additives have become depleted (see Figure 19).

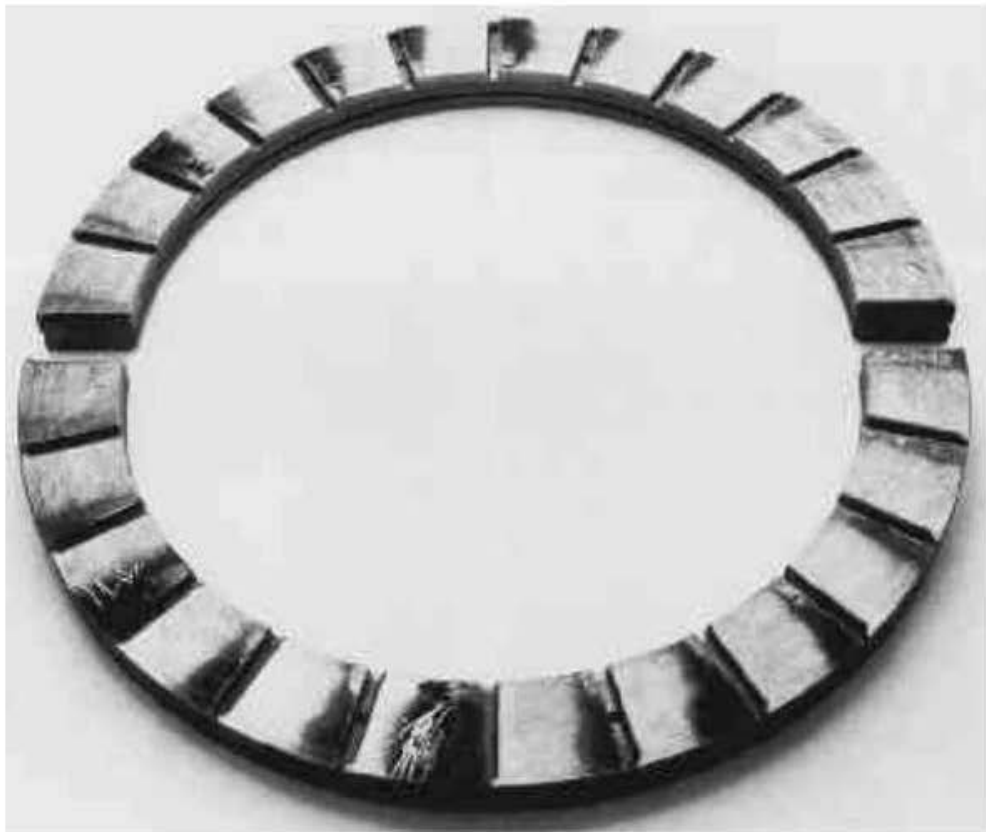
NOTE The black/brown deposit is easily removed using the thumbnail (see lowest segment).

Figure 20 — Deposit of oil carbon on a thrust bearing ring (material: steel/tin-based white metal)

Brown or black deposits appear on the bearing surface, but not as a result of chemical attack between the bearing material and the lubricant. The discoloration is due to very thin lacquer-like oxidized layers in areas of maximum temperature. It is relatively soft and can generally be removed using a solvent cleaning fluid or scratched off using a pointed instrument (see Figure 20).

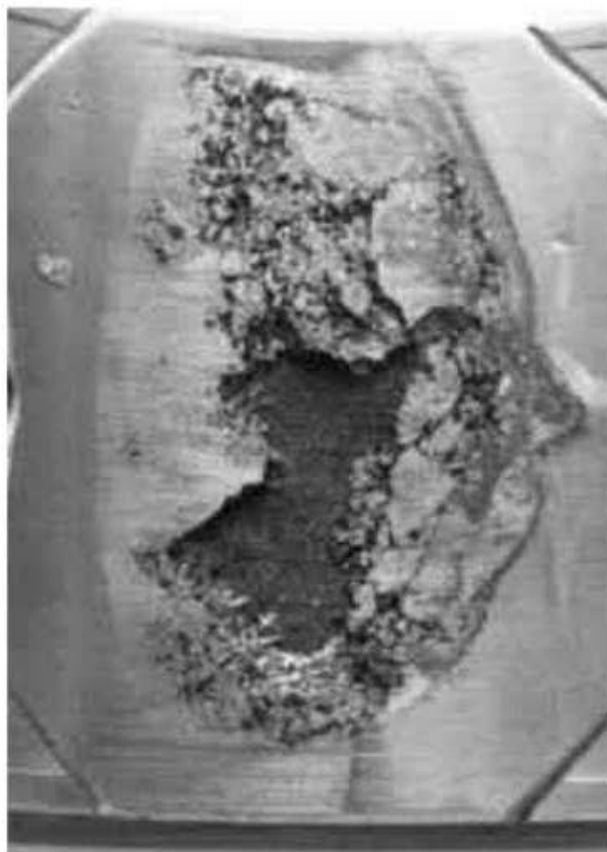
**Figure 21 — Radial segments with thermal cracks and worn material
 (material: steel/tin-based white metal)**

Thermal cracks have an irregular unsystematic orientation characteristic. These typical appearances can be characterized as creep deformation, traces of mixed lubrication and worn material (see Figure 21).

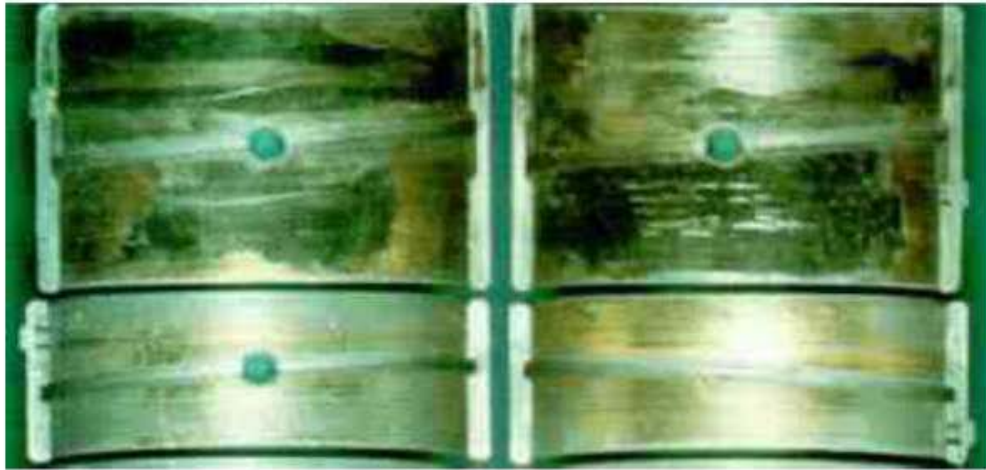
Figure 22 — Seizure on a multilayer plain bearing with totally detached intermediate layer, accompanied by melting, metal wear and severe scoring (material: steel/lead bronze/electroplated overlay)

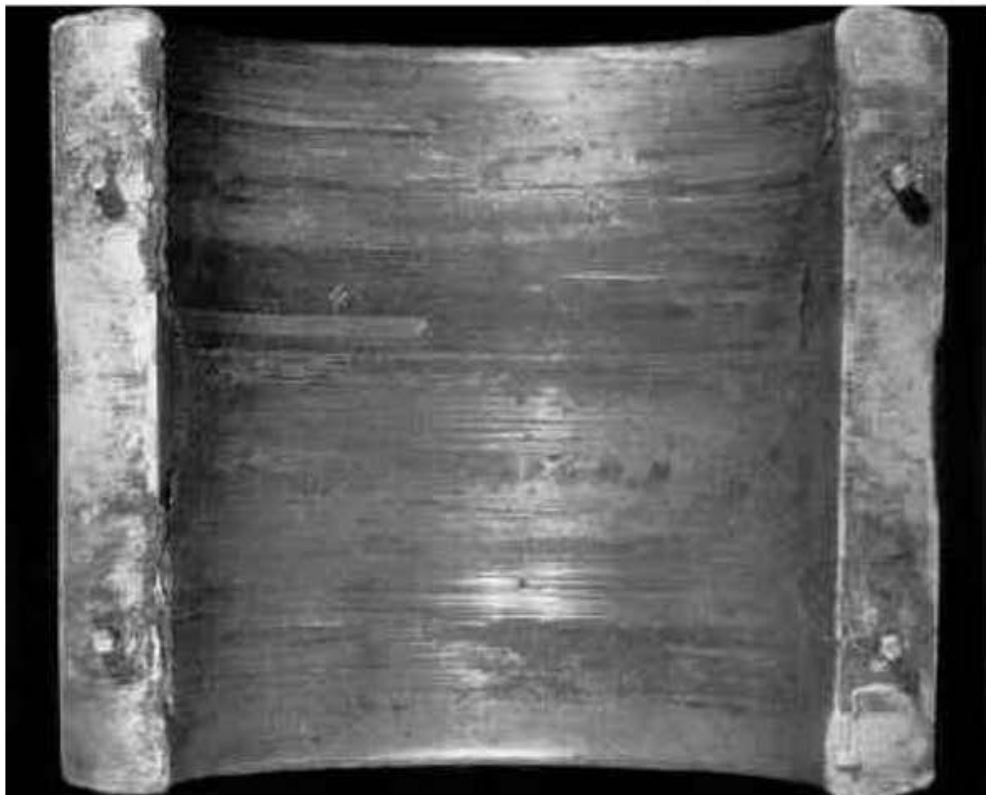
Figure 23 — Destruction of bearing metal due to loss of lubricant in a thick-walled bearing (material: steel/tin-based white metal)

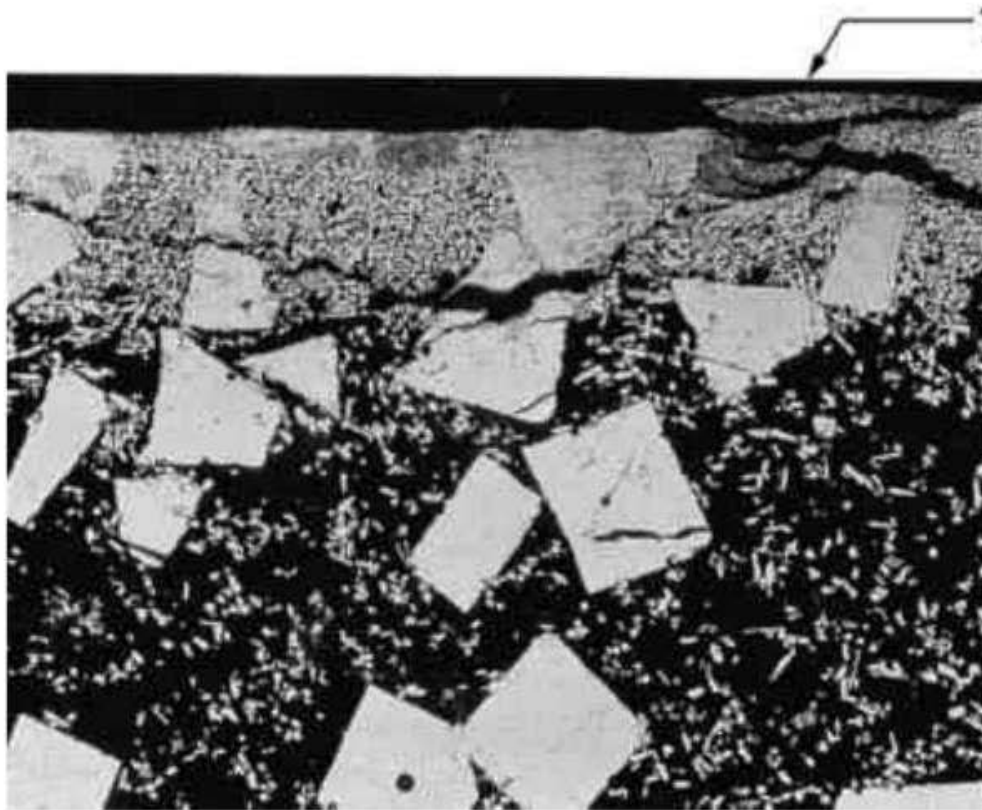
- 1 sliding surface

Figure 24 — Bearing metal molten along the surface due to overheating and loss of lubricant, followed by cracking of the (etched) bearing metal (material: steel/tin-based white metal)

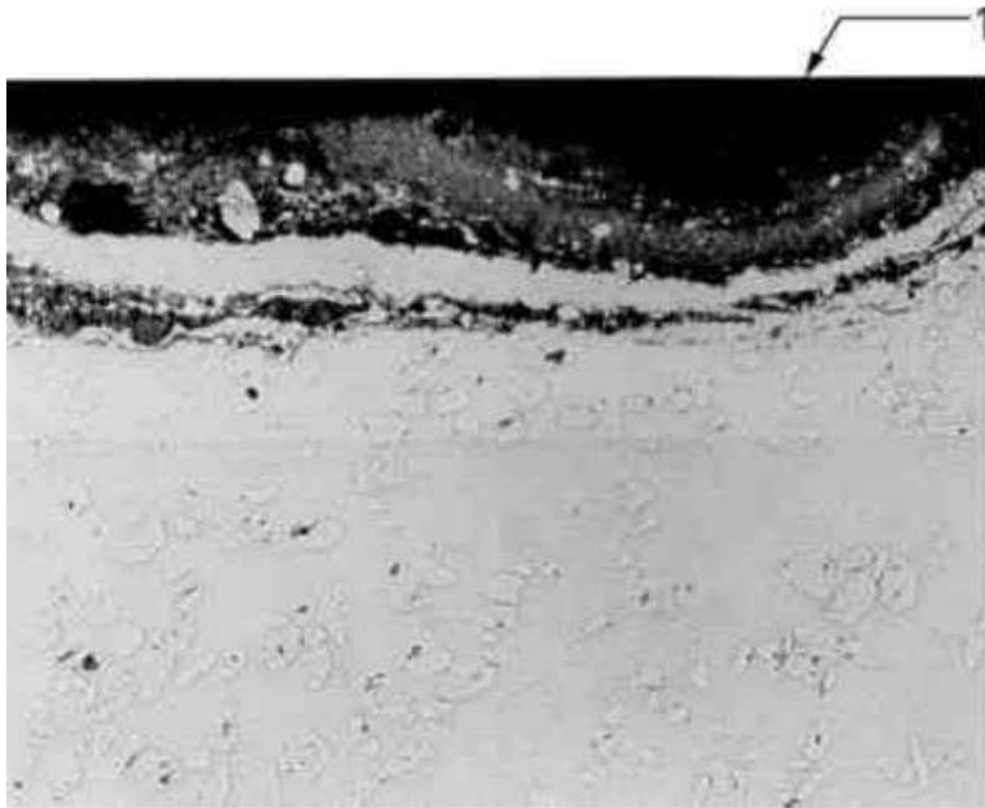
1 sliding surface

Figure 25 — Bearing metal layer exhibiting surface melting with entrained carbonaceous residue, unetched (material: steel/tin-based white metal)

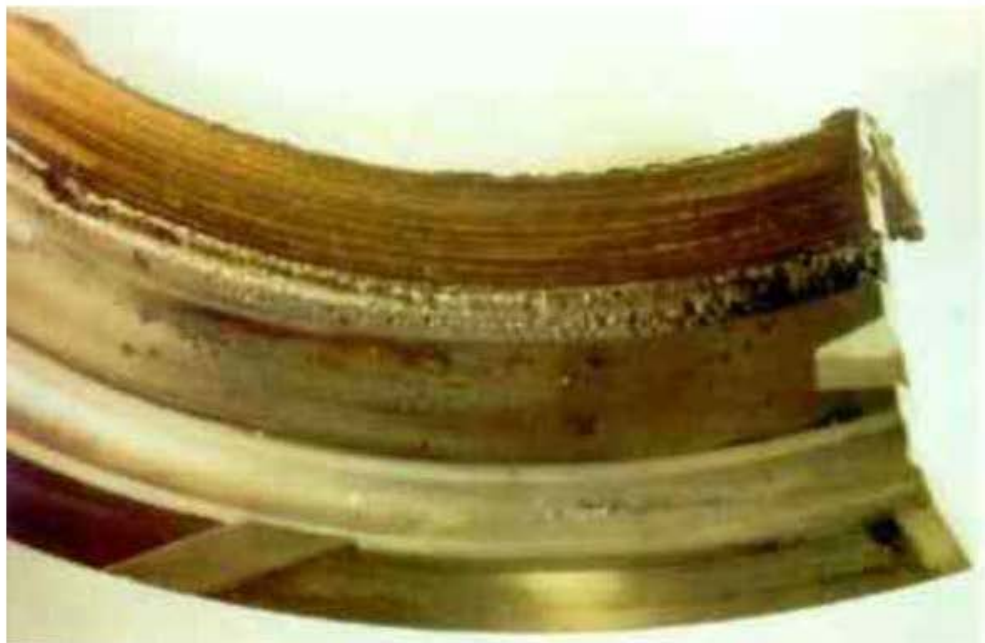
Figure 26 — Melting at the bearing edge and within the groove (material: steel/lead bronze/electroplated overlay)

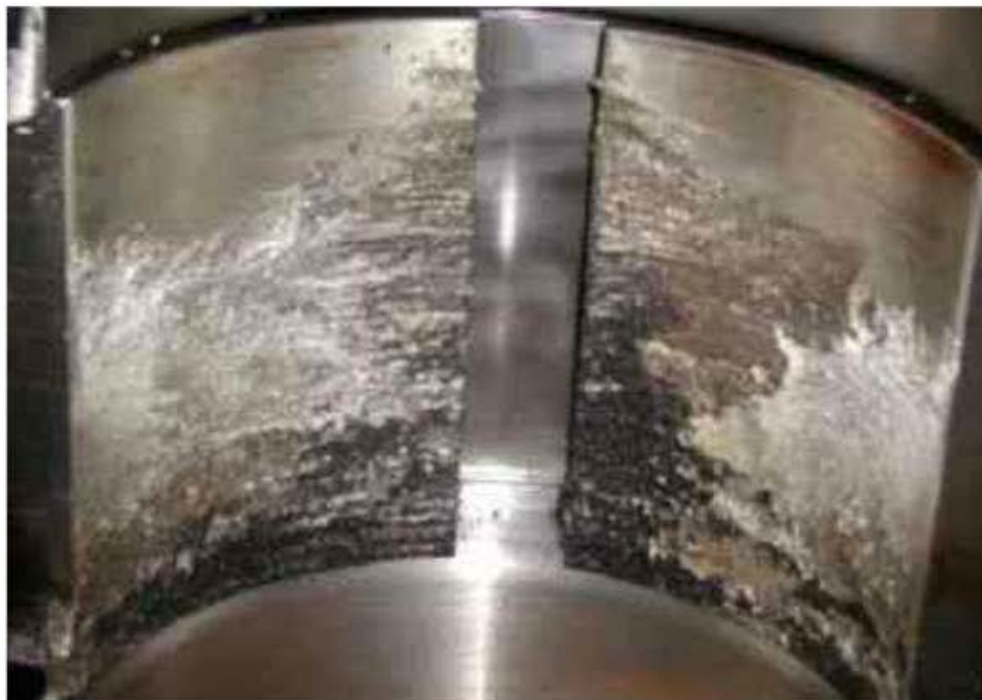
**Figure 27 — Coloured surface due to loss of lubricant, melting out, seizure
(material: steel/tin-based white metal)**

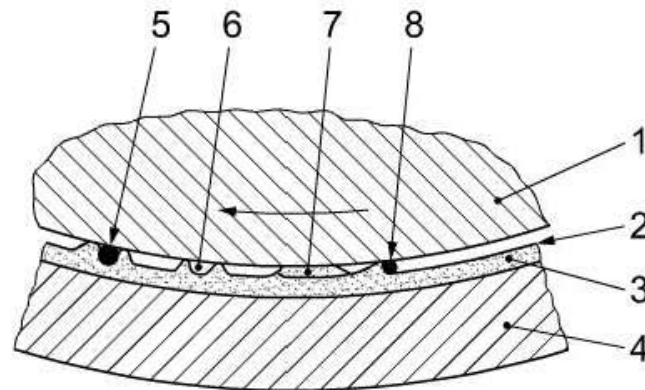
| 1 journal | 5 embedded particle usually with a highly reflective raised ring (halo) of bearing material around it (see also Figure 29) |
| 2 lubricant | 6 craters or scratches left by displaced particles (see also Figures 30 and 32) |
| 3 lining material | 7 particle of bearing metal from a damage site elsewhere in the bearing smeared onto the bearing surface (see also Figure 29) |

Figure 28 — Schematic diagram of possible embeddings

See Figure 28.

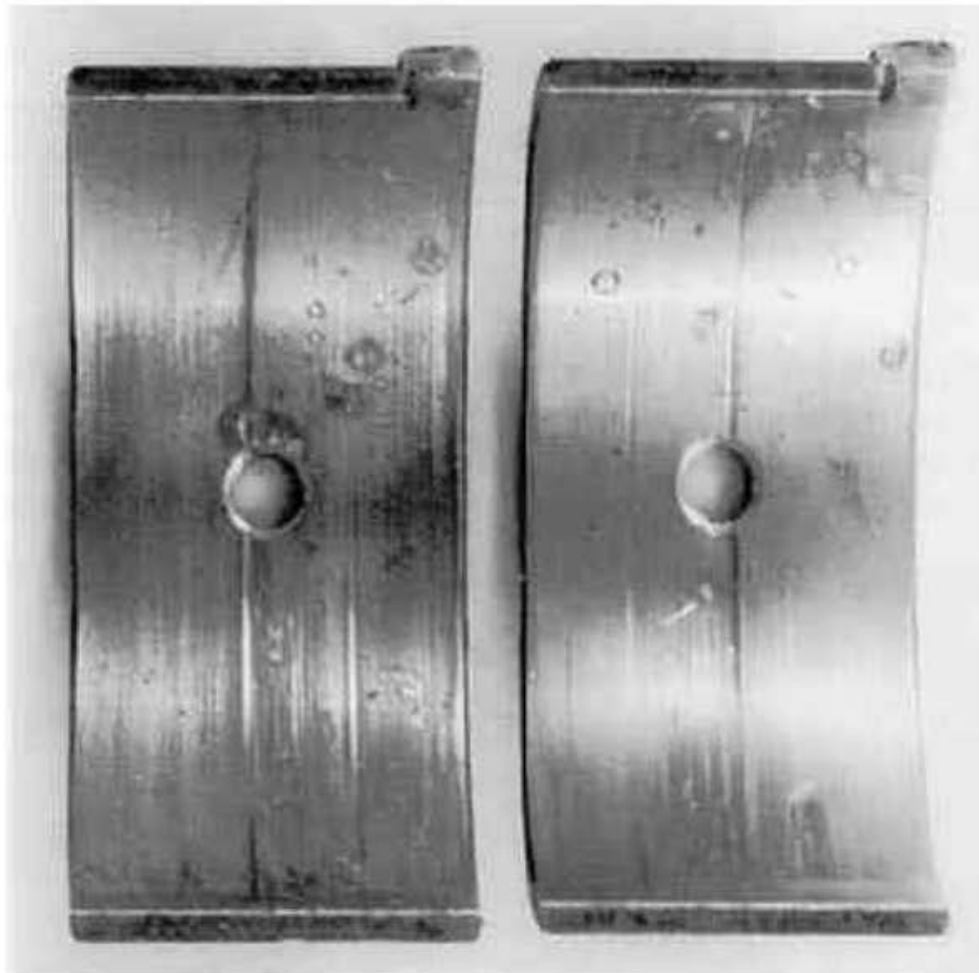
Figure 29 — Embedding of particles, characteristic of embedding, see Figure 28, and migration tracks (material: steel/AlSn)

Particle-migration tracks (see Figures 29, 32, 33 and 34).

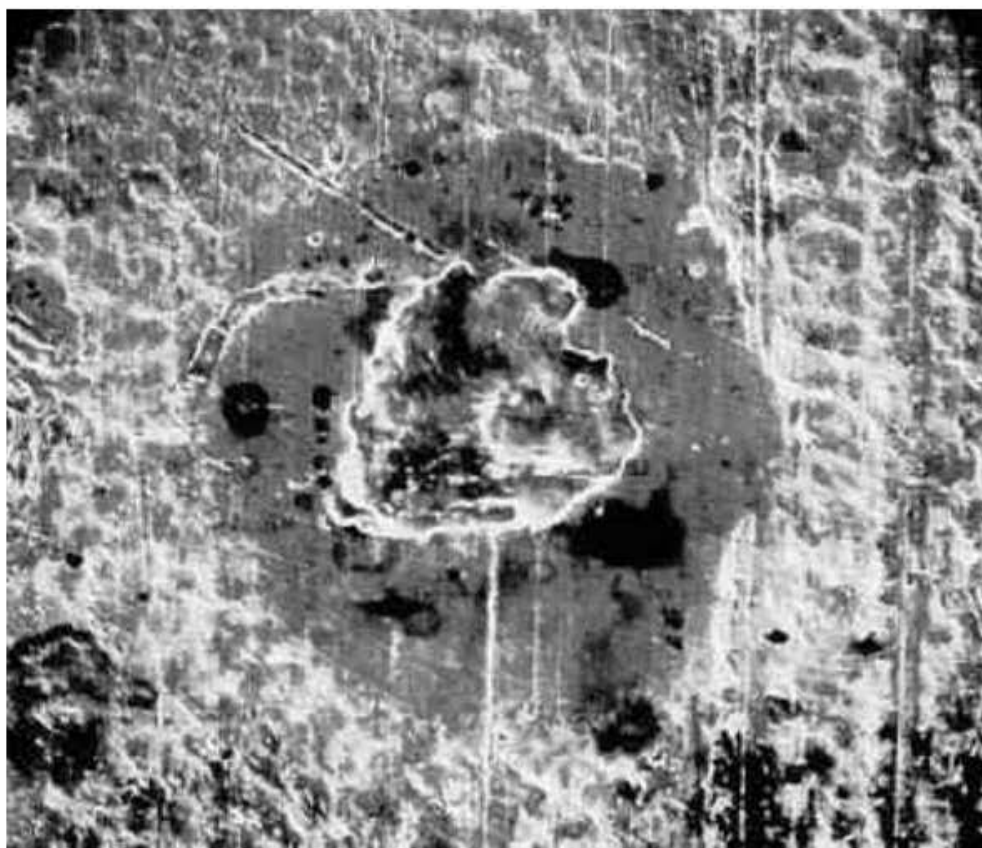
Figure 30 — Crater left by displaced particle surrounded by reflective ring (halo), characteristic of embedding, see Figure 28, label 6, (material: steel/lead bronze/electroplated overlay)

Particles embedded in the bearing surface, surrounded by raised bearing metal displaced as the particle is embedded. The raised bearing metal appears as a highly reflective halo around the embedded particle (see Figure 30). The halo comes in contact with the counterface. Traces of mixed lubrication and worn material occur.

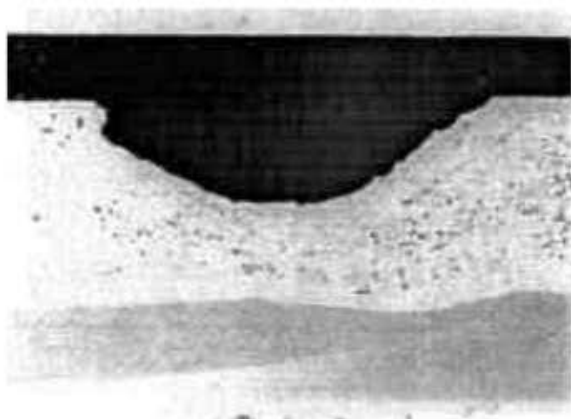
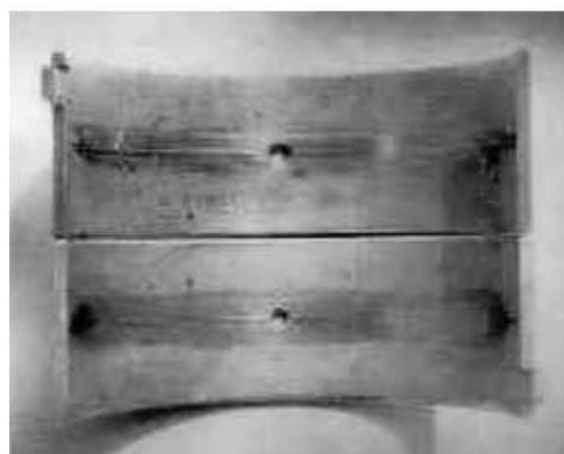
a) deformation at the lining surface cross-section

b) (material: steel/lead bronze/electroplated overlay)

Figure 31 — Deep circumferential score with displaced bearing metal alongside

Scoring (see Figure 31)
