ISO
7146-1

Plain bearings — Appearance and characterization of damage to metallic hydrodynamic bearings —

Part 1: General

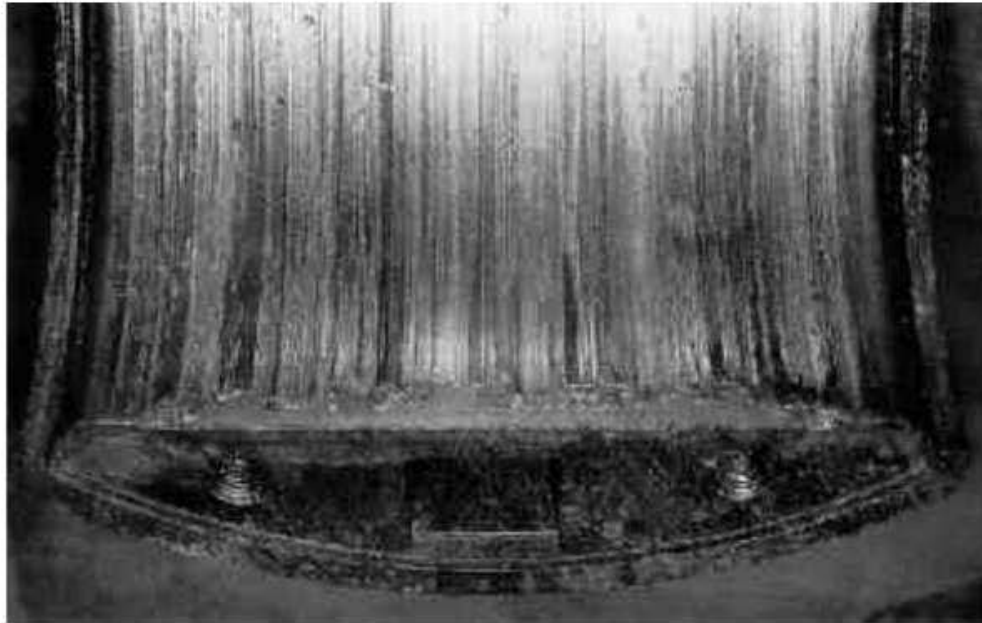
Figure 32 — Cement mill bearing with contamination by cement particles entrained by the oil as a result of damaged seals. Particle-migration tracks are visible (material: steel/tin-based white metal)

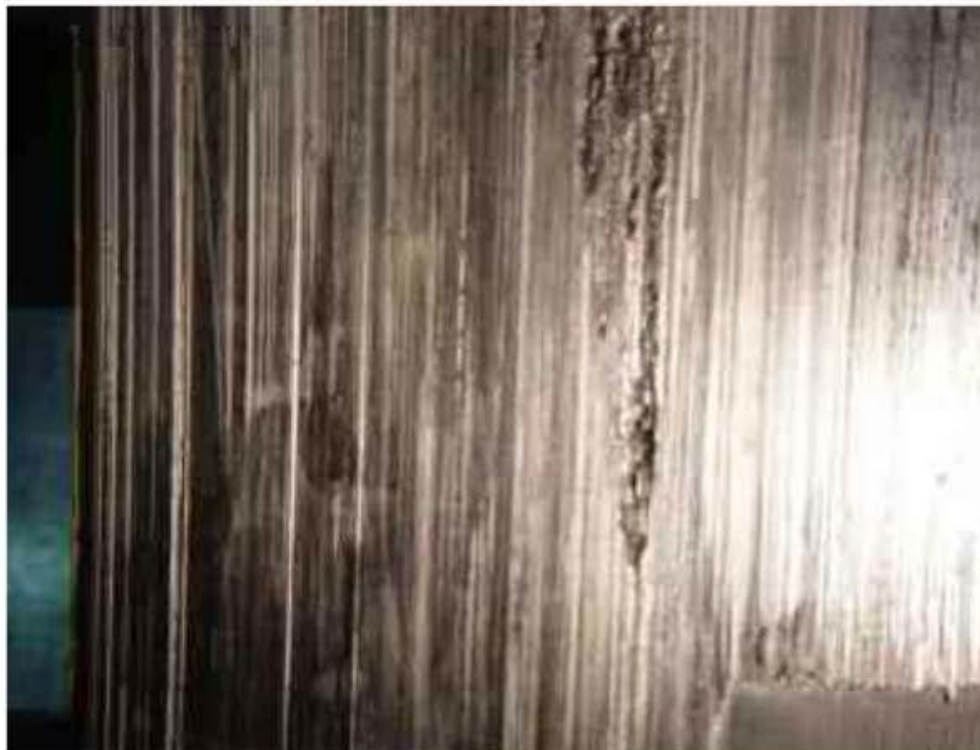
Figure 33 — Contamination by foreign particles containing Fe — particle-migration tracks are visible

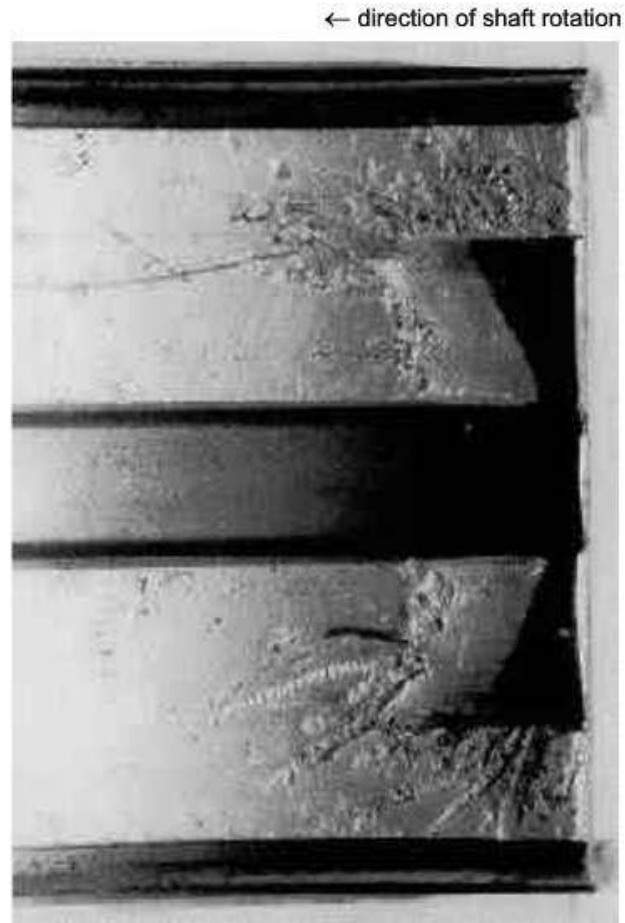
Figure 34 — Particle-migration tracks concentrated to the pocket area of a thin-walled bearing (material: steel/AlSn)

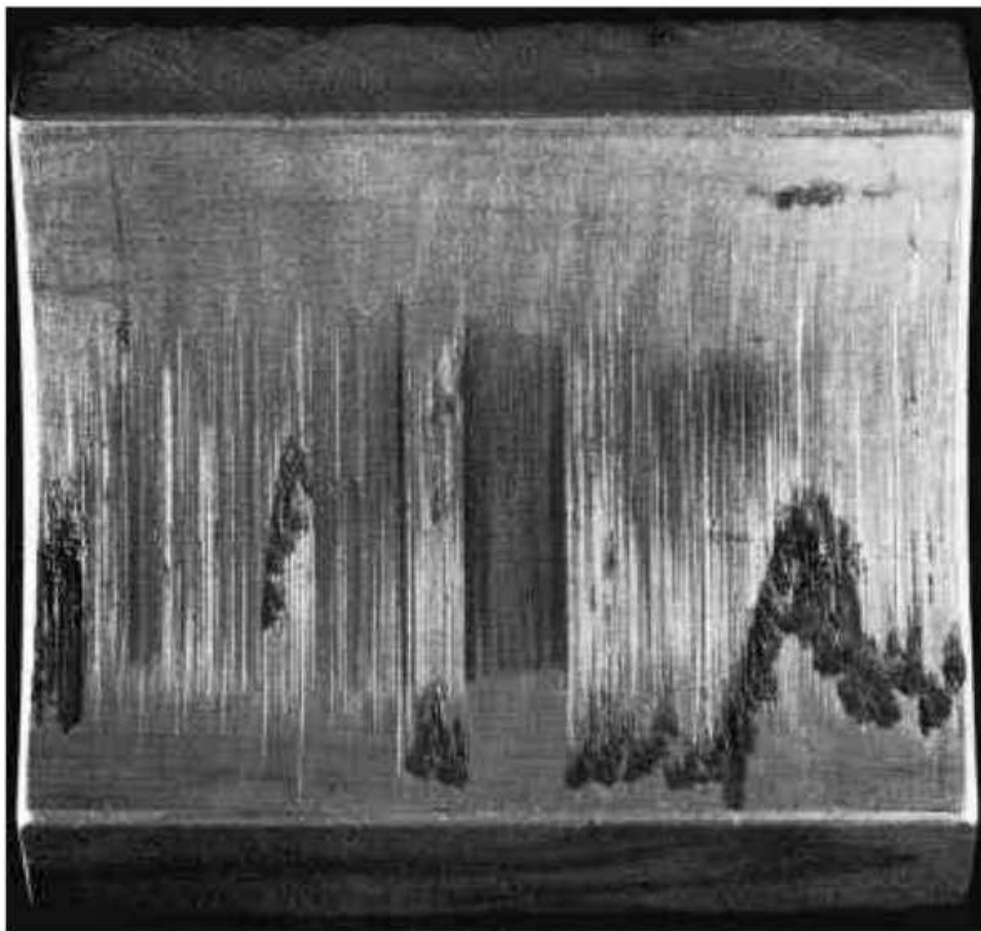
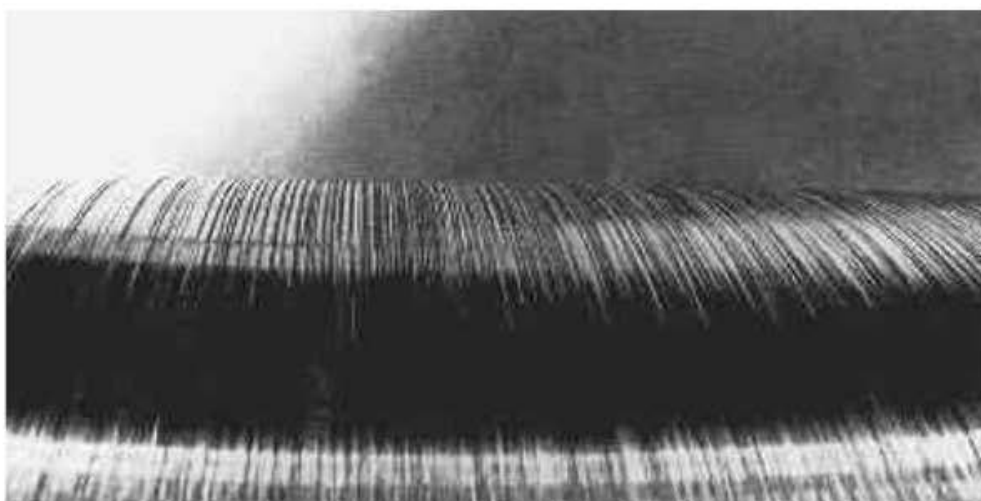
a) wire wool on a journal pad (material: steel/tin-based white metal)

b) wire wool on the shaft

Figure 35 — Attack caused by abrasive and adhesive effects in the initial stage (wire wool) (material: steel)

The formation of wire wool can be caused by hard foreign particles partially embedded in the bearing surface cut into the rotating shaft thereby removing material from the shaft surface. Wire wool formed in this way can also be once more embedded in the bearing metal and usually brings about total failure very quickly (see Figure 35).

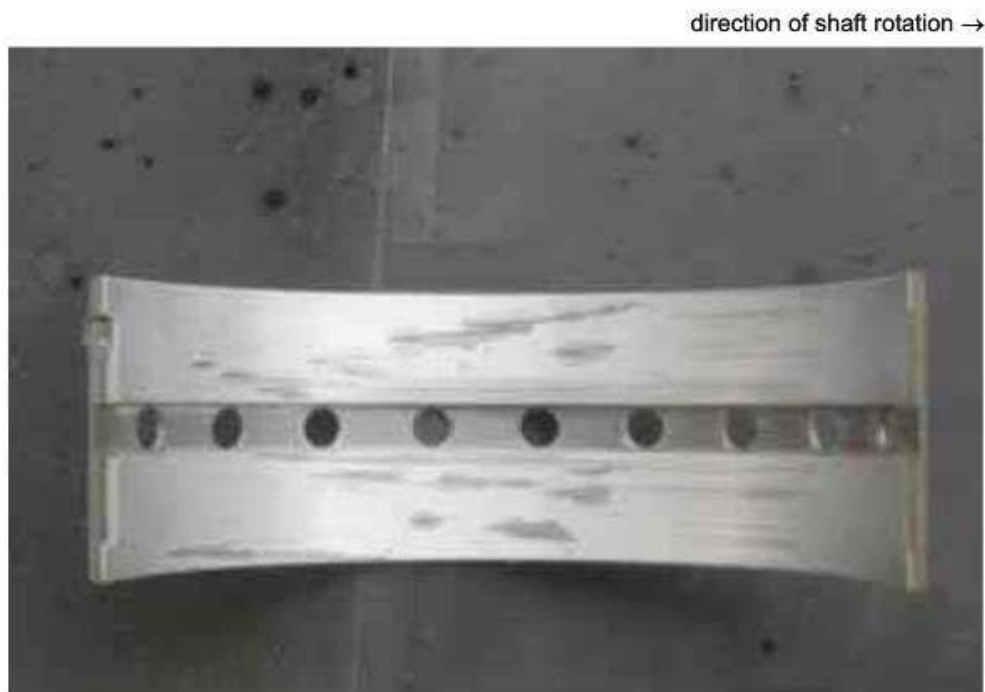
Figure 36 — Chevron-like defect caused by particles from iron nitride compound layer of nitrided shafts (material: steel/lead bronze/electroplated overlay)

Chevron appearances are particle-migration tracks generated by hard particles. The chevrons point in a direction opposite to the direction of rotation of the journal (see Figure 36).

Chevron appearances: The migration tracks are caused by particles originating from the surface of nitrided journals. Particles with magnetic properties spall from the journal due to insufficient grinding and removal of the white friable layer.

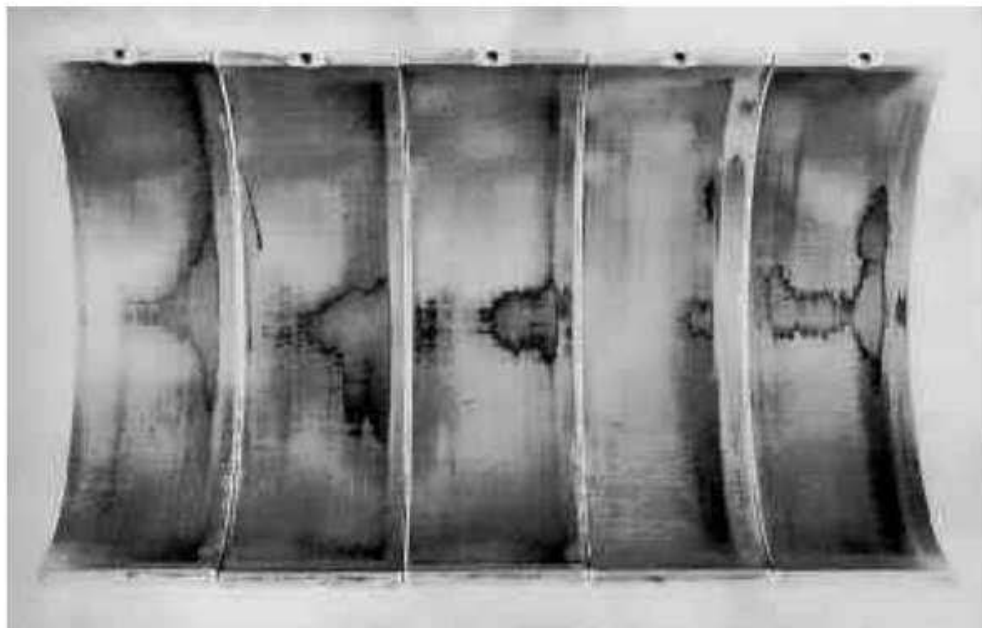
**Figure 37 — Discoloration of the bearing surface in the main loaded zone by tribochemical reaction
(material: steel/lead bronze/electroplated overlay)**

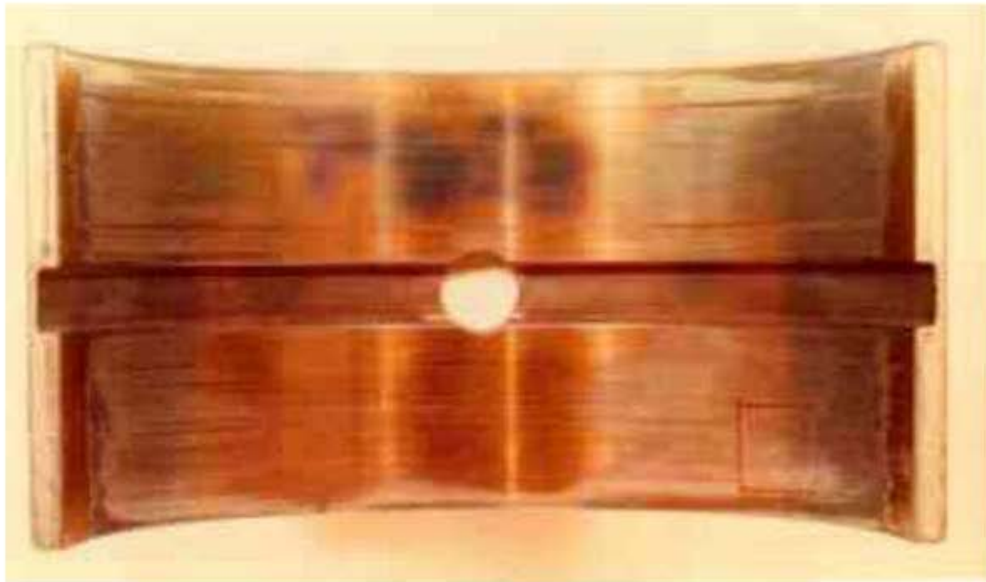
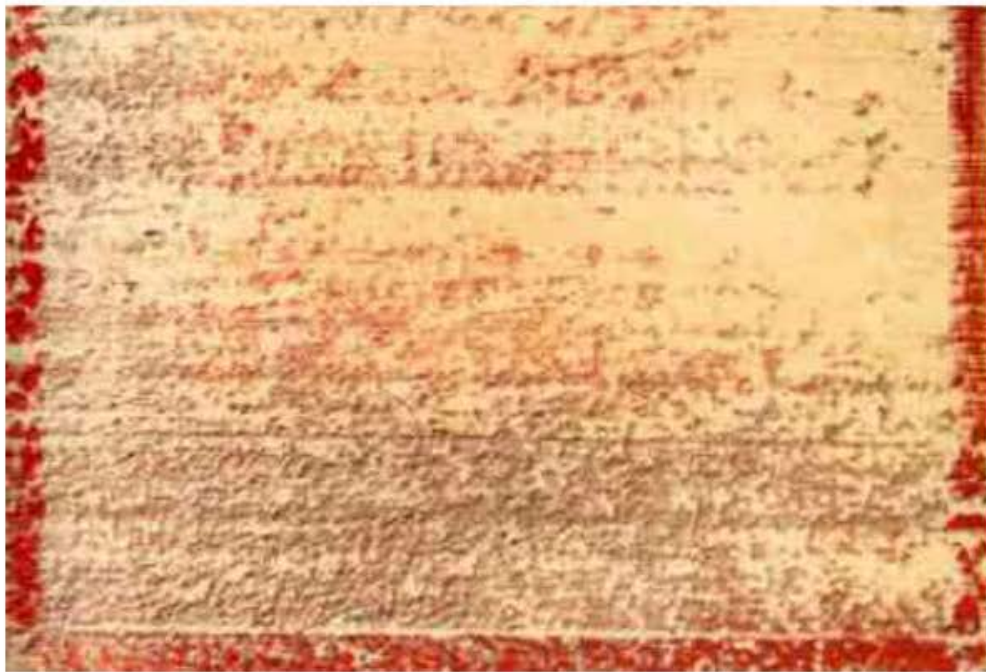
a)

b) section from the marked area of Figure 38 a) at increased magnification

Figure 38 — Corrosive detachment of the overlay in the area of the oil hole and selective corrosive detachment on the right-hand side of the bearing lining (material: steel/lead bronze/electroplated overlay)

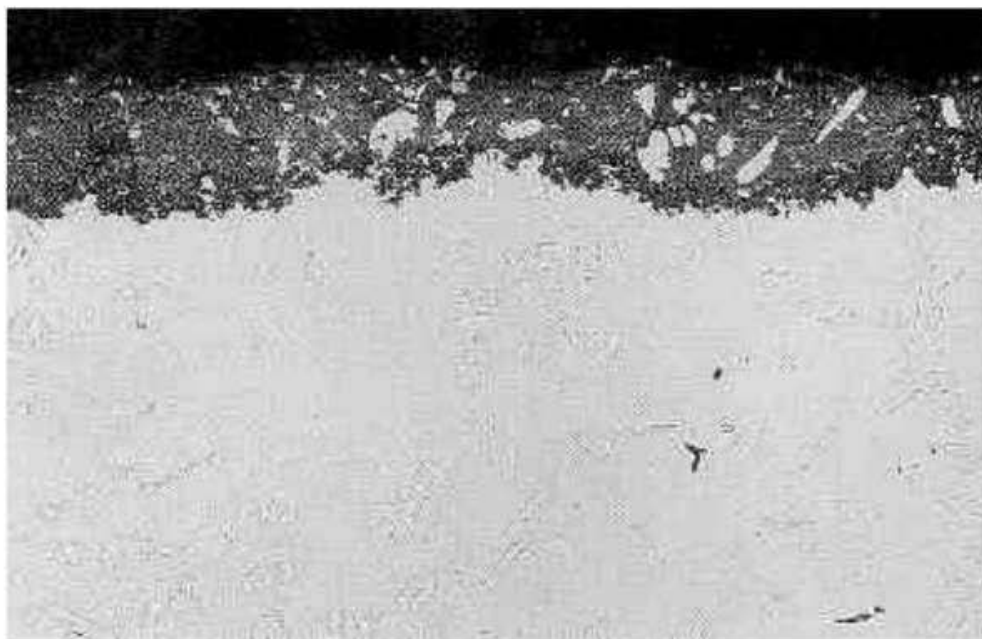
Figure 39 — Tin oxide corrosion due to water in the oil, unetched (material: steel/tin-based white metal)

For corrosion due to water in the oil, the critical water concentration depends on oil and operating conditions, but can occur generally when water is present in excess of 1 % volume fraction.

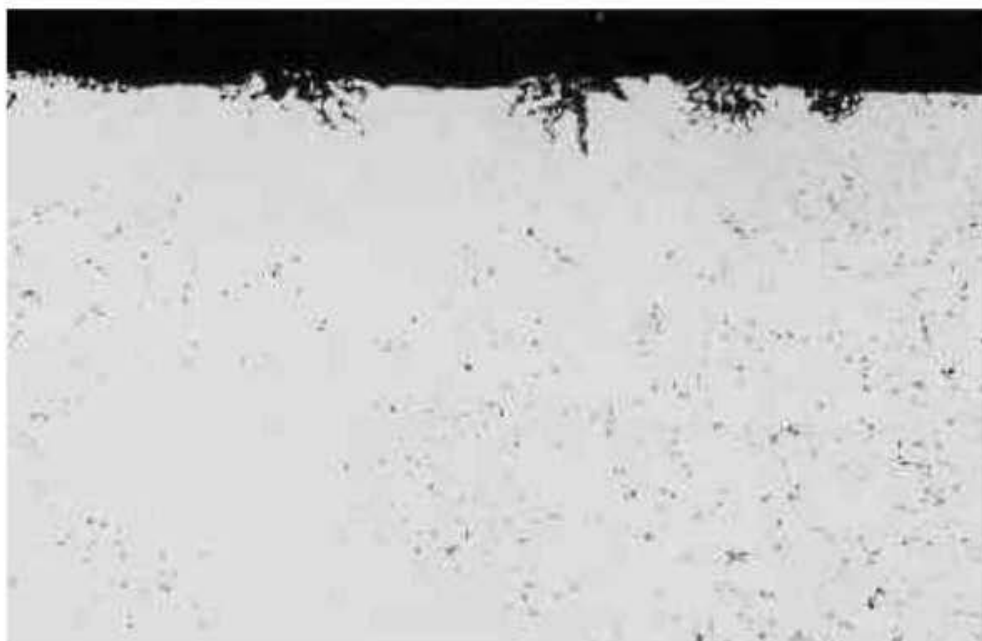
Figure 40 — Corrosion of the surface layer with selective attack on copper and lead in a tin-based material, unetched (material: steel/tin-based white metal)

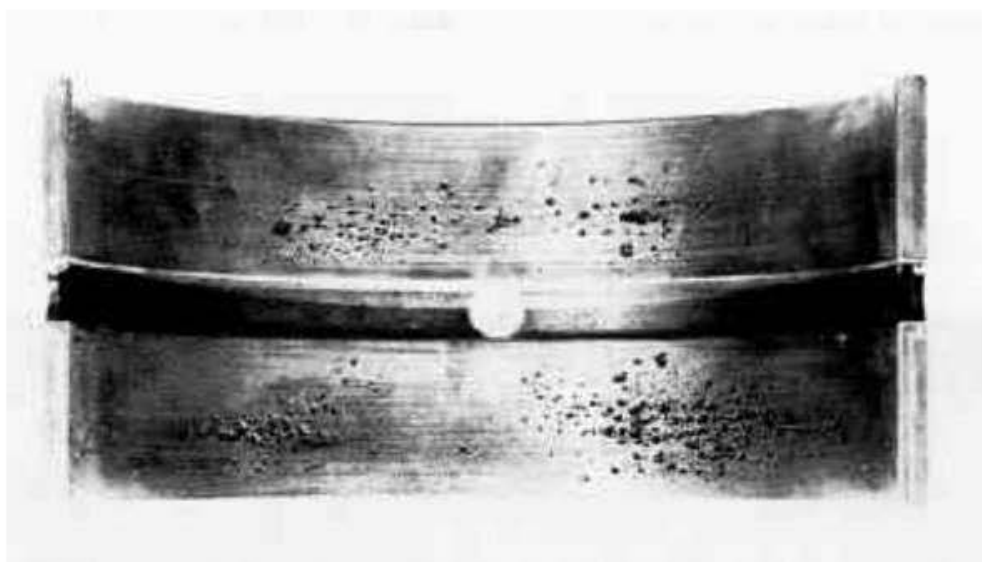
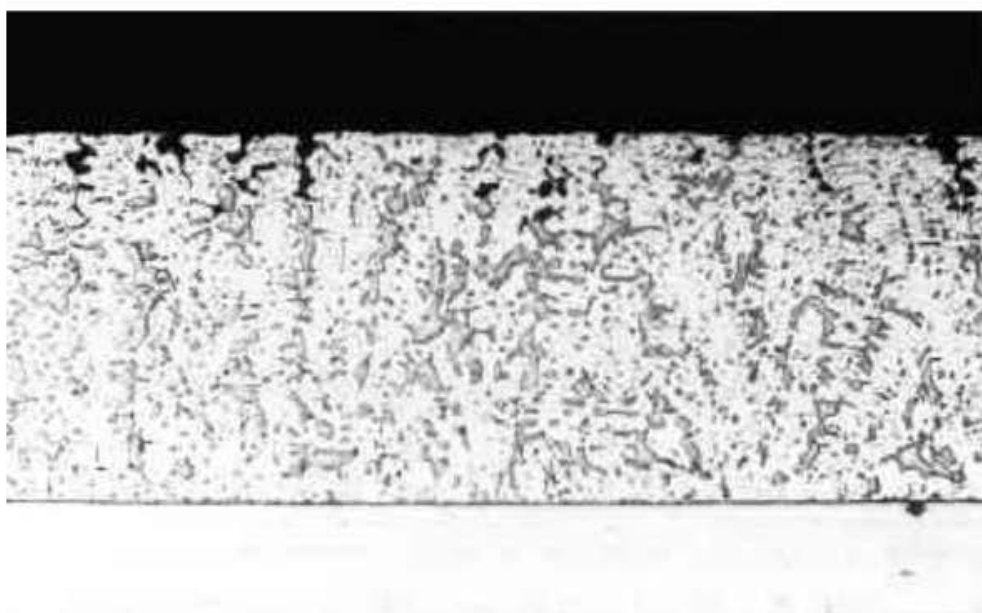
Figure 41

a) structure weakened by corrosion of lead phase after wear of overlay
(material: steel/lead bronze/electroplated overlay)

b) microcut at increased magnification (material: steel/lead bronze/electroplated overlay)

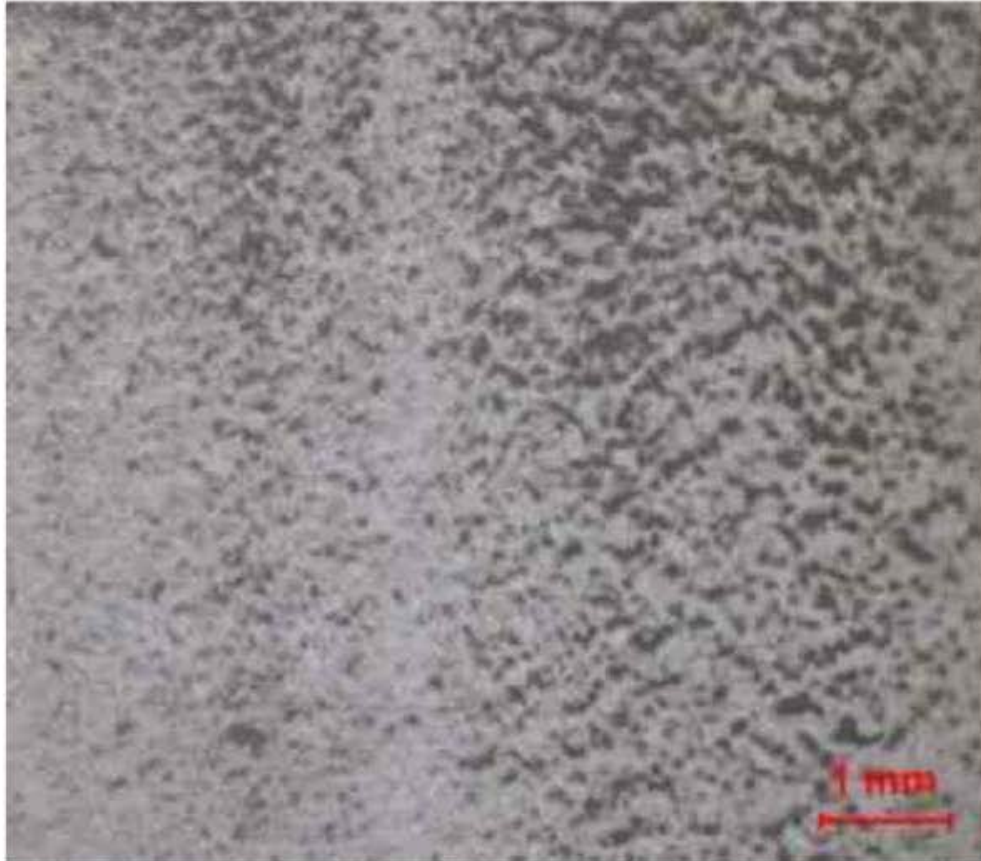
Figure 42 — Deposit of oil carbon on galvanic surface

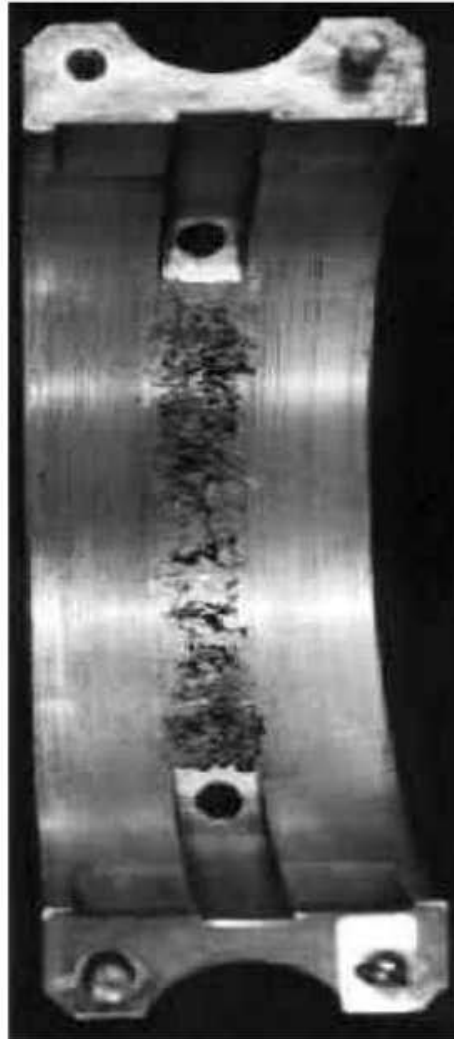
Figure 43 — Typical cavitation erosion on a thick-walled bearing (material: steel/tin-based white metal)

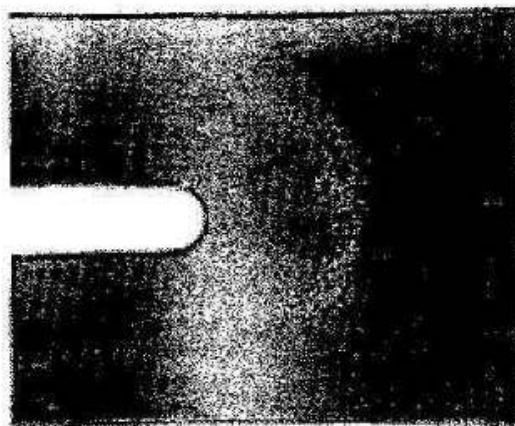
Figure 44 — Typical cavitation erosion on a thin-walled bearing

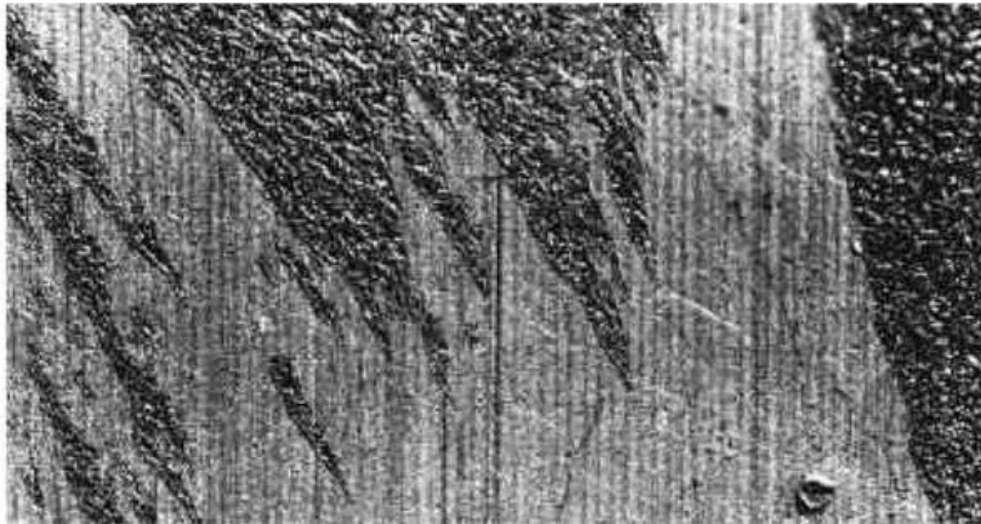
**Figure 45 — Surface of a plain bearing attacked by electro-erosion
(material: steel/lead bronze/electroplated overlay)**

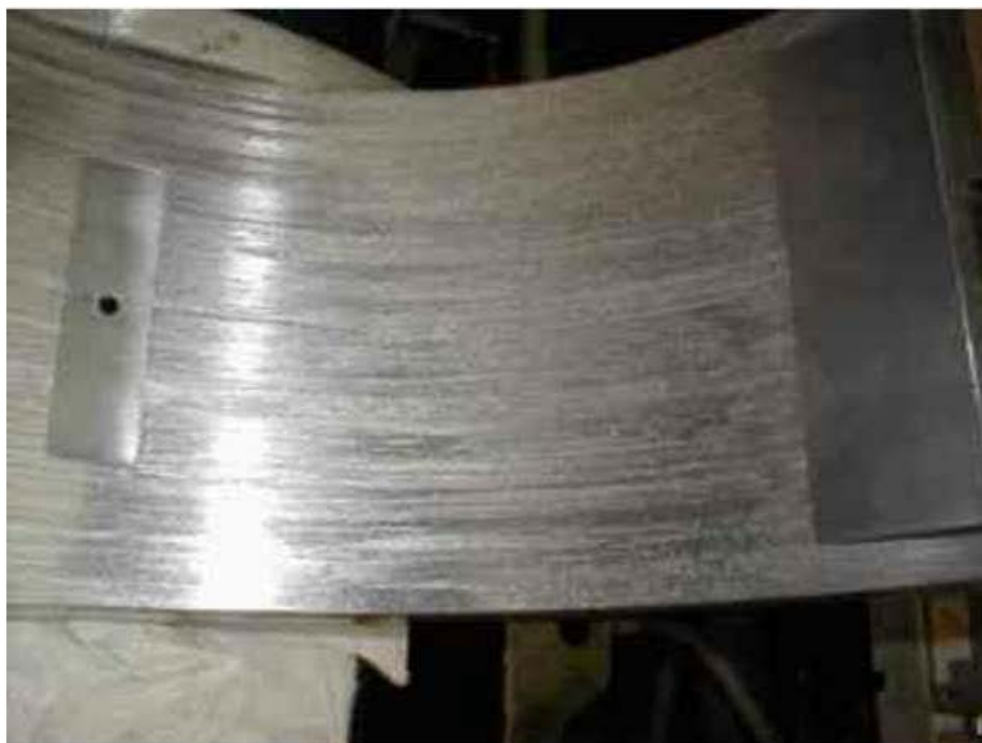
Figure 46 — Formation of electric arc craters

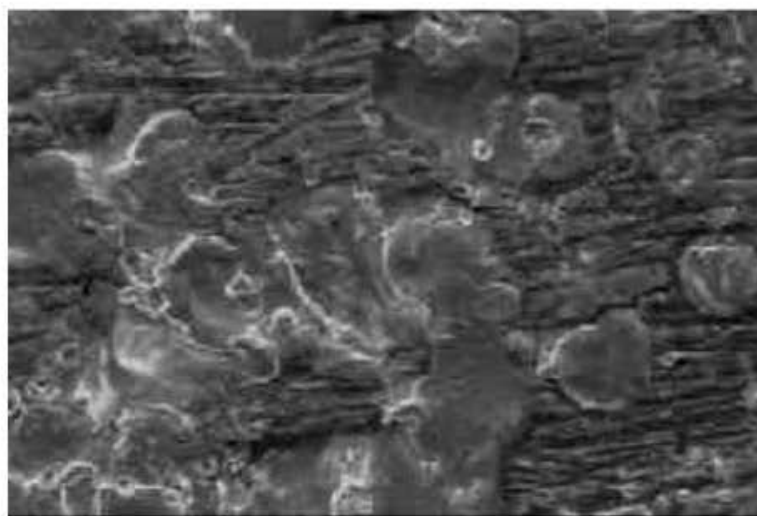
Figure 47 — Electric arc craters at increased magnification (material: tin-based white metal)

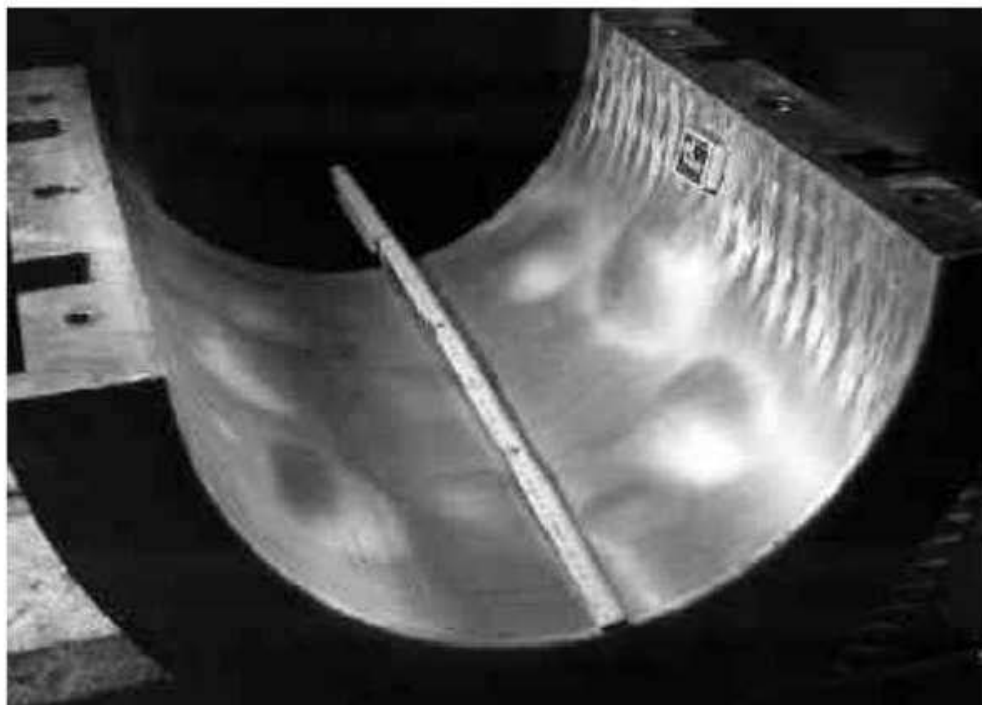
Figure 48 — Layer with loss of bond and formation of typical blisters, arising from hydrogen inclusion in the steel (material: steel/tin-based white metal)

For thick-walled bearings: loss of bond between white metal and steel. White metal forms typical blisters (see Figure 48).

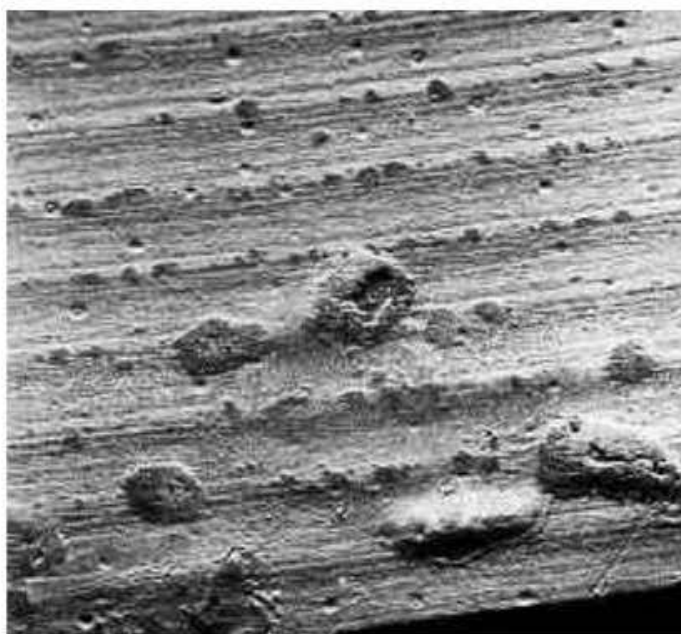
**Figure 49 — Hydrogen inclusion arising from electroplating — small pores and larger blisters, partially perforated during running
(material: steel/lead bronze/electroplated overlay at increased magnification)**

For electroplated layers: formation of pores with typical blisters on the layer surface (see Figure 49).

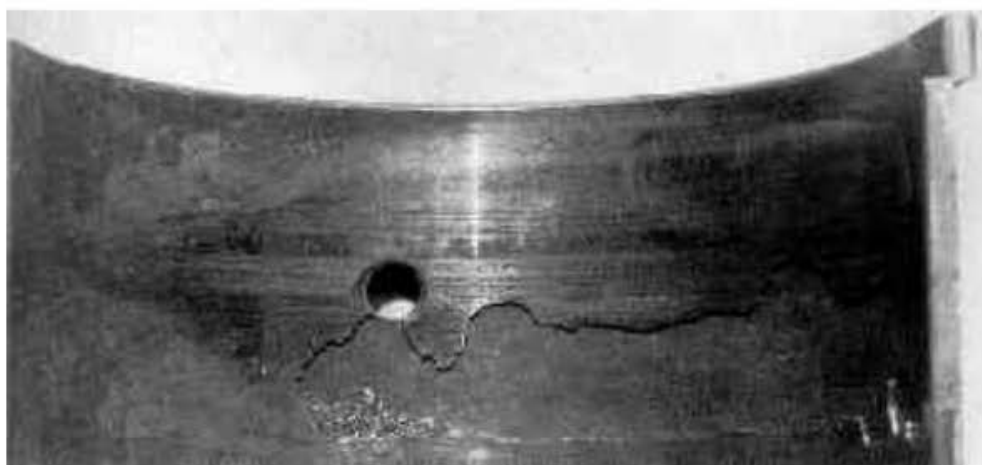
**Figure 50 — Loss of white metal showing a break with clearly defined borders
(material: steel/tin-based white metal)**

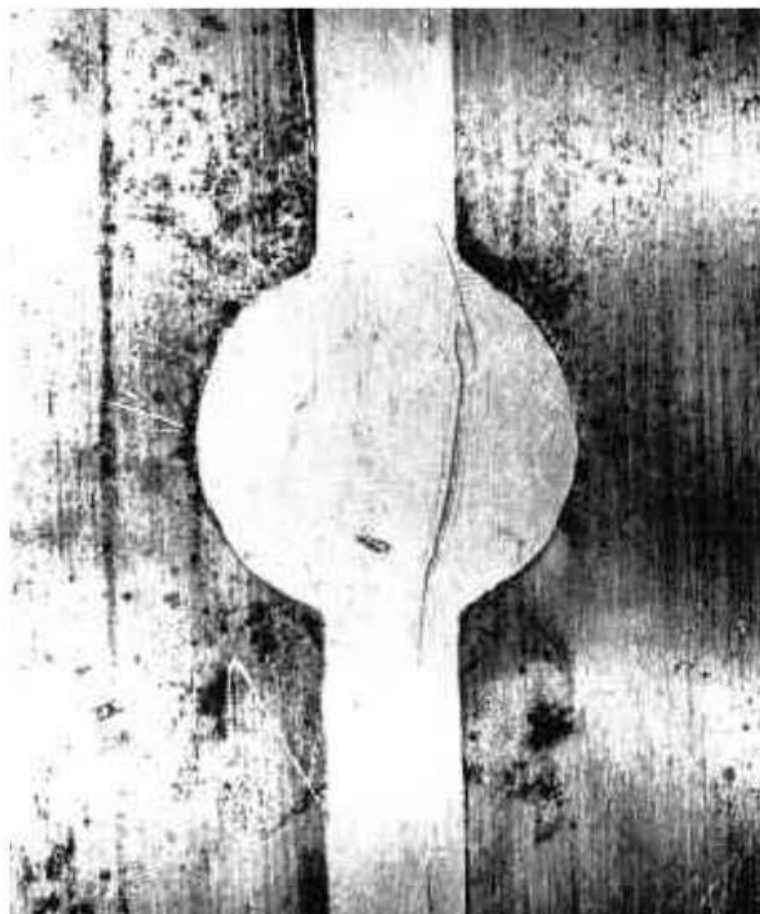
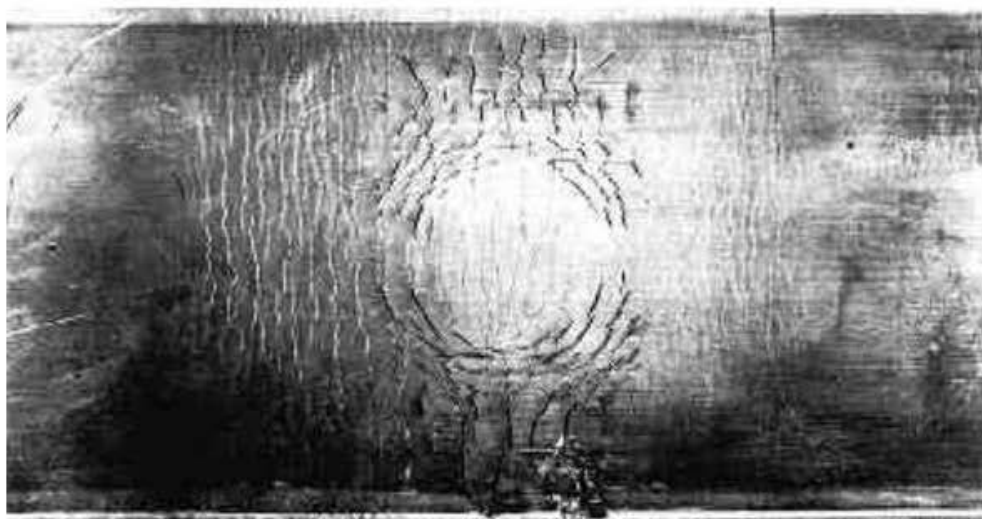
a) bearing back with appearance of oil groove and hole in the housing (material: steel)

NOTE The black cracks were produced during operation and contain dirty oil. The pale cracks at the sides were produced by bending the bearing open.

b) bearing surface

Figure 51 — Recessed areas (bearing back and corresponding bearing surface) — Insufficient support locally of the bearing in relation to the load

Fatigue tracks (see Figure 51).

If the bearing is not sufficiently supported (oil grooves on the bearing back), a local dynamic overload can also occur (see Figure 51).

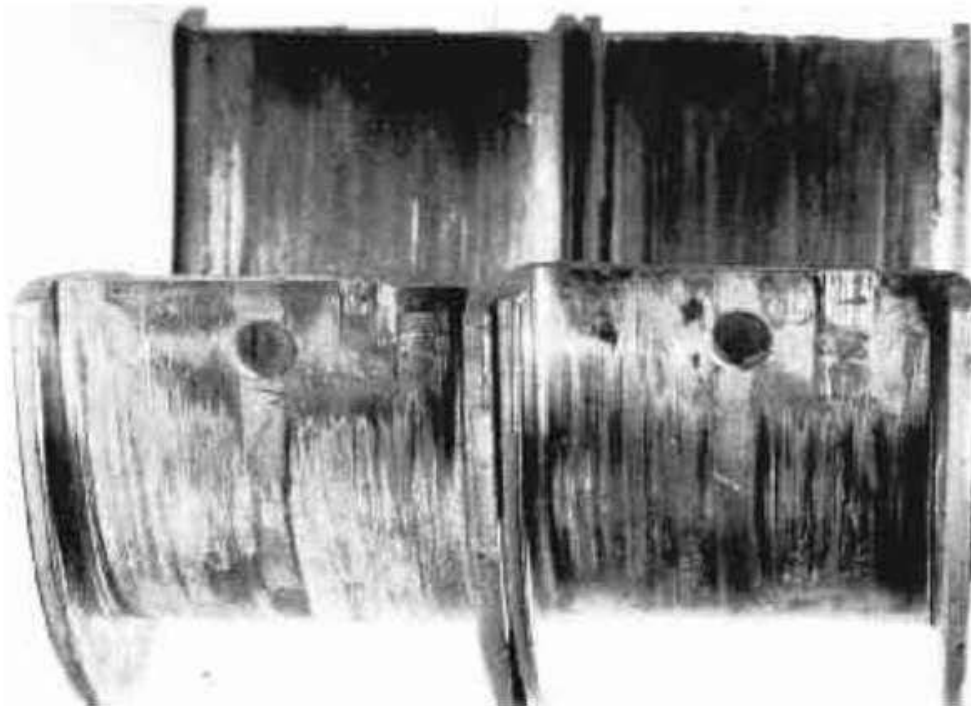
NOTE The locating nicks have been flattened towards the bearing surface.

**Figure 52 — Circumferential scoring on the bearing back resulting from slippage
(material: steel/lead bronze/electroplated overlay)**

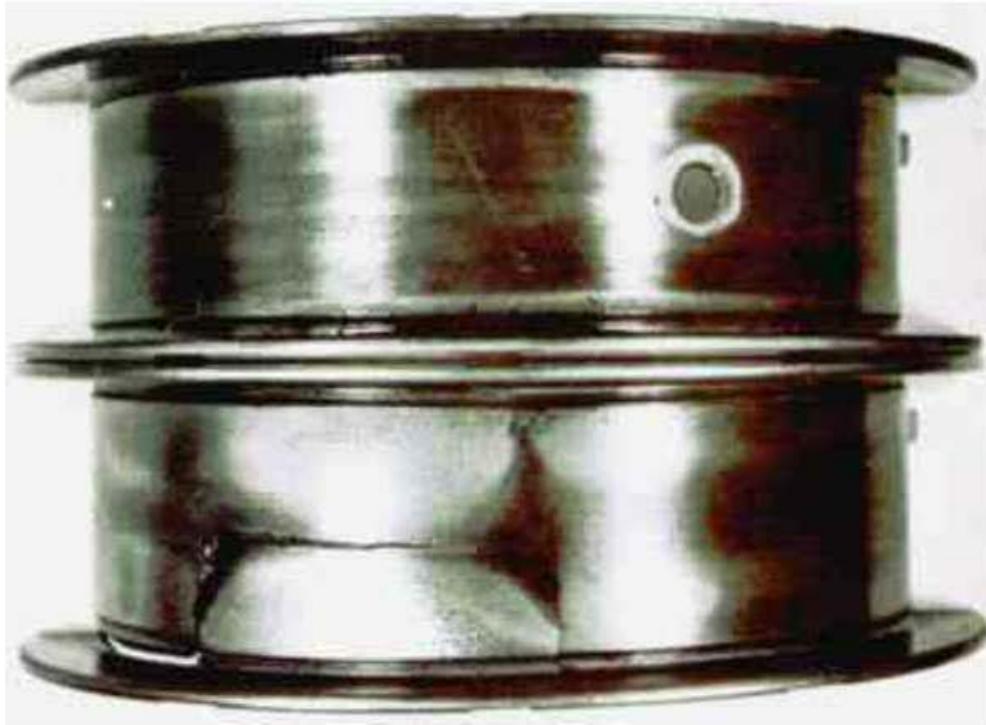
Figure 53 — Fracture of the steel backing (commencing at the top in an axial direction within an area exhibiting pronounced signs of movement, progressing circumferentially and finally deviating towards the flange)

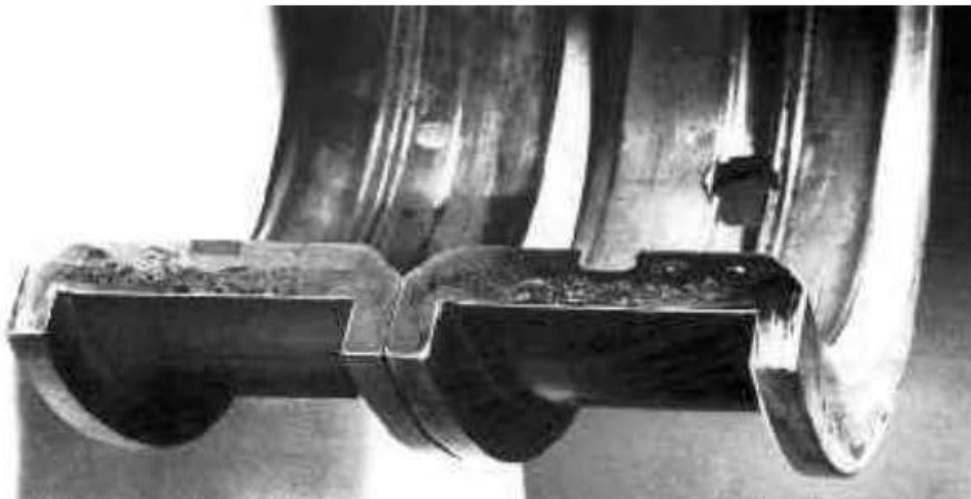
Figure 54 — Pitting and transfer of material at the joint faces

Particle, fretting debris or carbonized oil between bearing back and housing (see Figure 54)

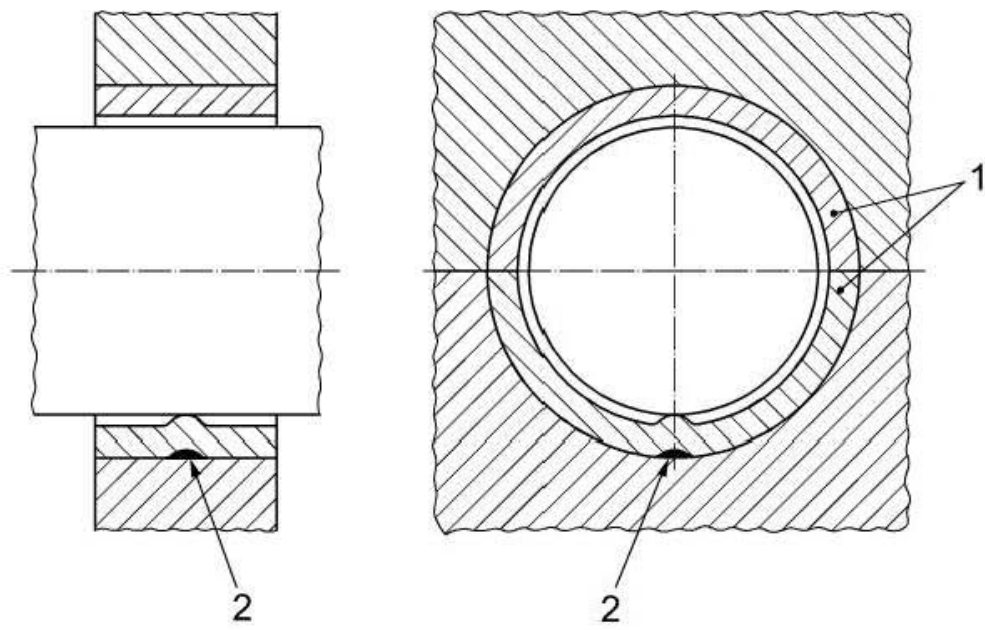
- Key**
- 1 backing
 - 2 foreign particle

Figure 55 — Schematic diagram of a foreign particle trapped behind a bearing and the resulting raised area

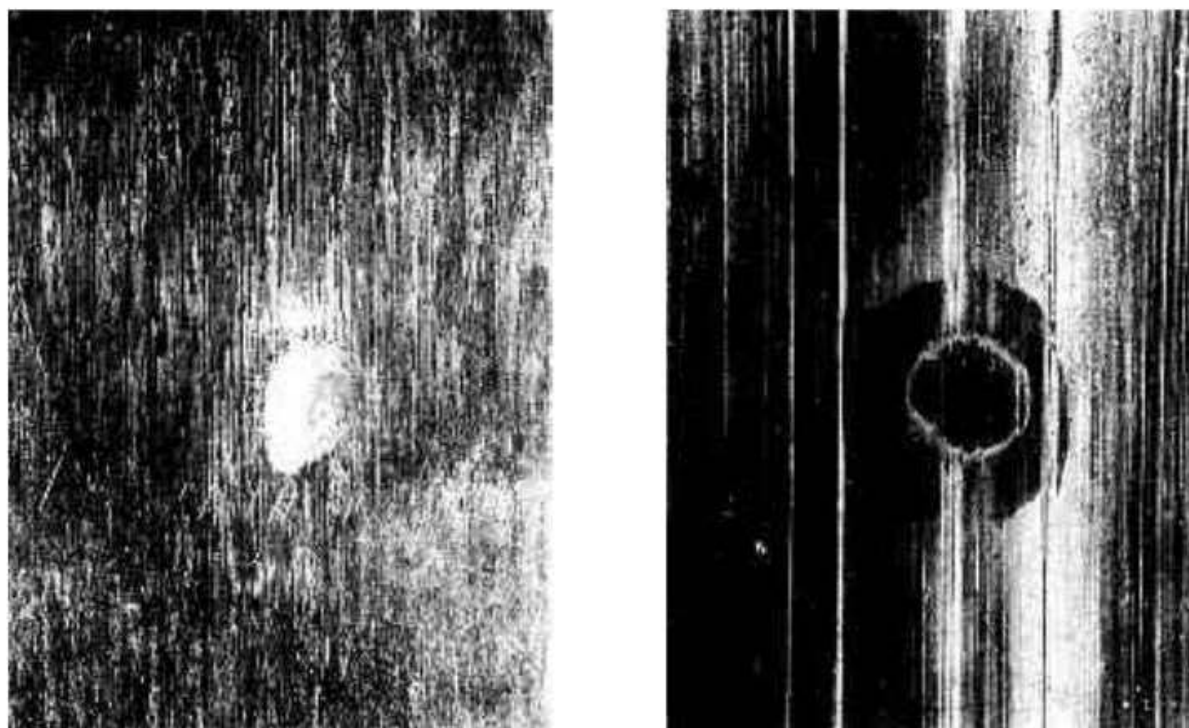
Figure 56

- a) indent on bearing back left by particle trapped between bearing and housing
(material: steel/lead bronze/electroplated overlay)
- b) corresponding worn metal raised area of bearing bore
(material: steel/lead bronze/electroplated overlay)
